**2013 ANNUAL REPORT**  
to the  
**TENNESSEE STATE BUILDING COMMISSION**

Prepared by:  
Tony Guzzi, Vice-President, Preservation and Site Operations  
The Hermitage, Home of President Andrew Jackson  
4580 Rachel's Lane  
Hermitage, TN 37076  
615.889.2941 ext. 225  
Fax 615.889.9289  
[tguzzi@thehermitage.com](mailto:tguzzi@thehermitage.com)

February 4, 2013

**THE HERMITAGE MANSION  
FIRE PROTECTION SYSTEMS ASSESSMENT**

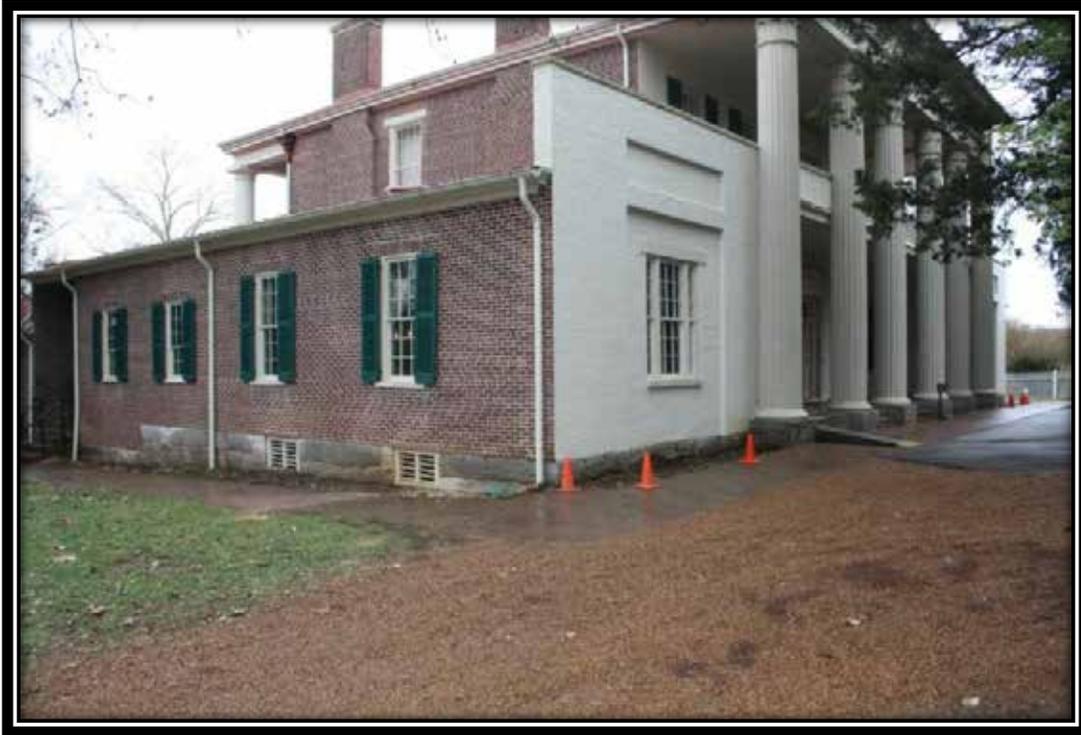
*This photo shows the slope toward the mansions' south elevation. French drains south, east, and west of the Hermitage mansion will capture and divert water away the foundation.*

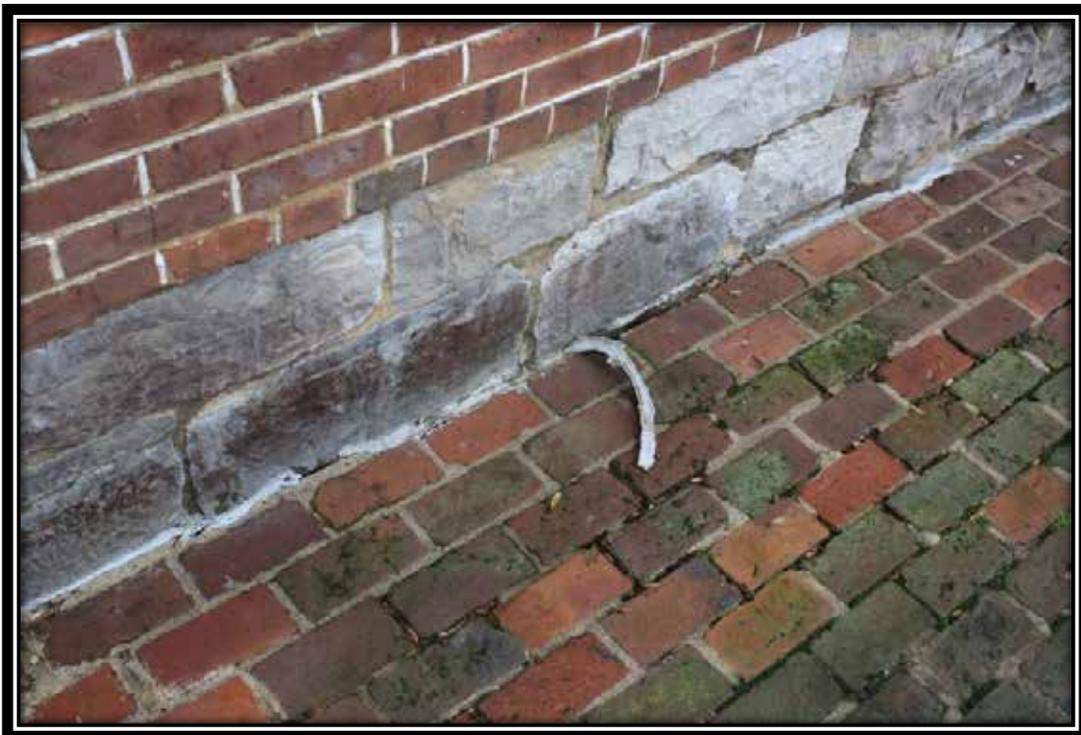
*This image shows brick and problematic caulk joints next to the mansion's foundation.*

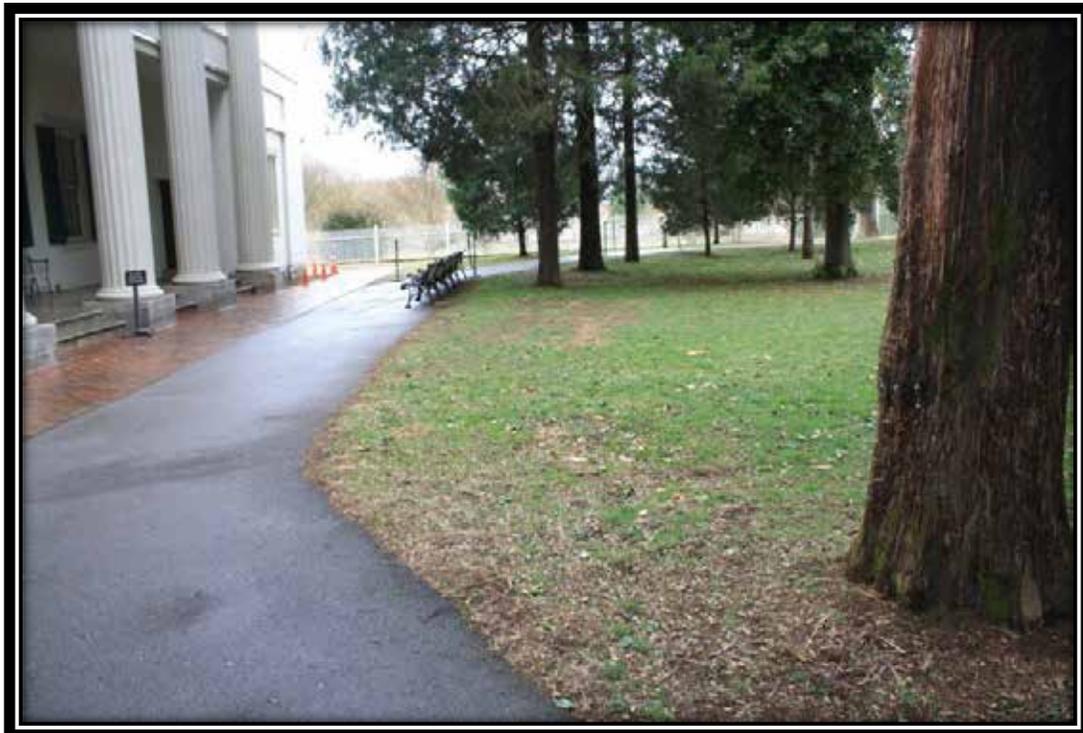
*These asphalt and brick on concrete pathways will be replaced with pervious pavement and brick on a sand and gravel base to allow for better drainage.*

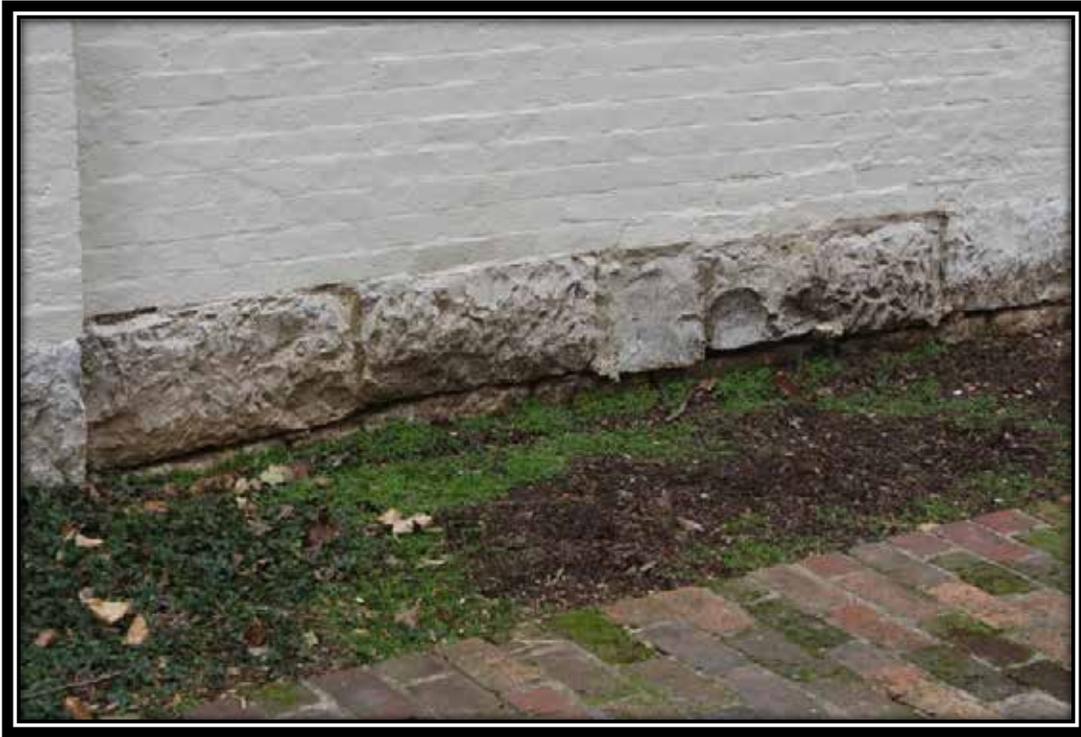
*This image shows the deterioration of the mansion foundation joints.*

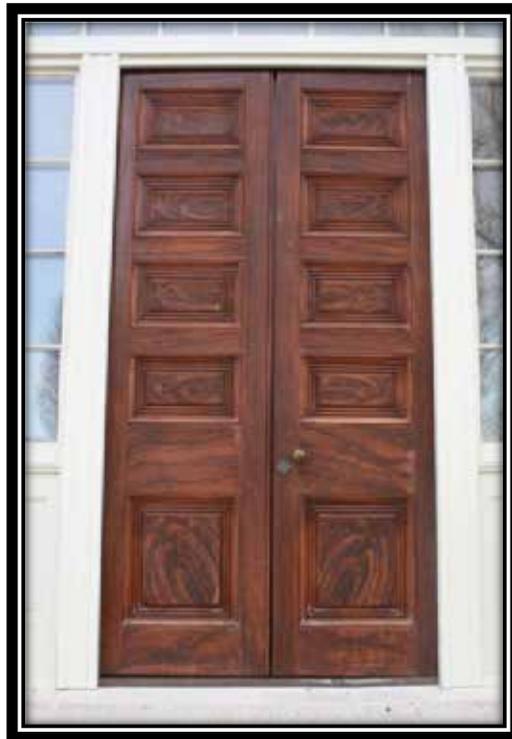
*This image shows one of the reproduction grain painted doors. Exposure to weather and repeated use resulted in severe rot in the bottom of the door and deterioration of the graining.*

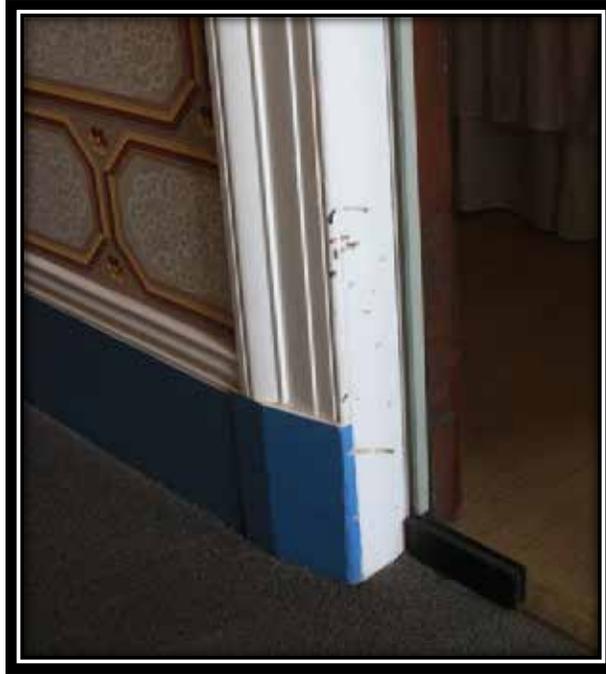
*Typical condition of door casings in public hallways.*

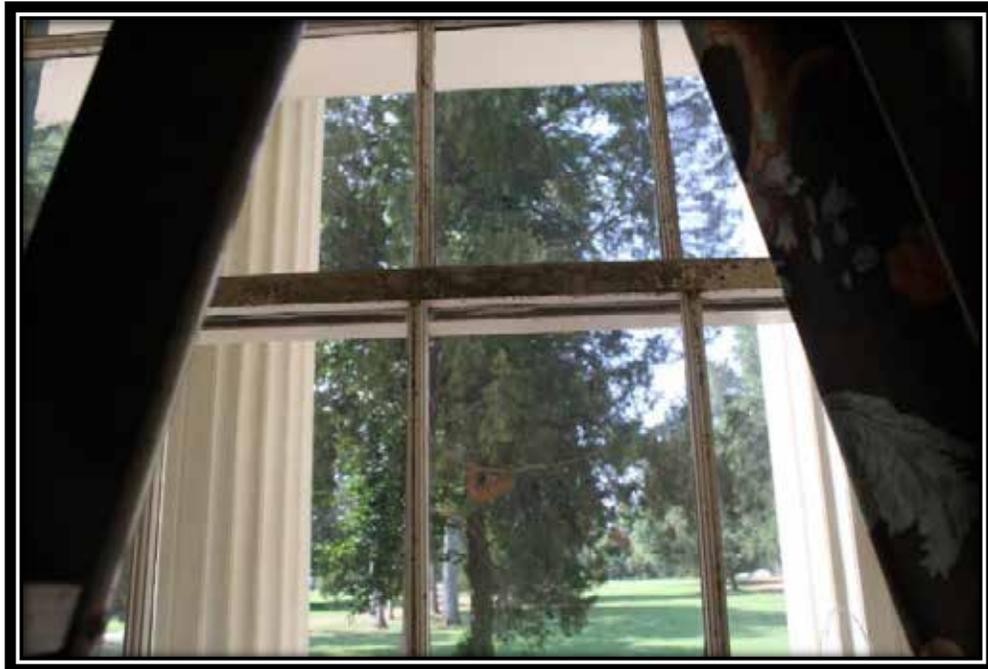
The existing Hermitage mansion interior storm windows do not provide for a tight seal between the storm window and the original mansion windows. The resulting condensation that forms inside the space between the two windows during weather extremes has created mold issues and will eventually cause wood rot. The original impetus for the installation of these windows was filtering UV light so it would not damage the historic collections. These windows were not designed to be vapor barriers. The Hermitage has assembled a team of preservation architects, HVAC engineers, and conservators to study the window problem and devise a solution. The total cost of this analysis is projected to be \$15,000 and it will be partly funded through a National Endowment for the Humanities Preservation Assistance Grant. Once a solution is devised, the Hermitage will assess if ample funds exist to proceed with manufacturing and installing a redesigned window.

*Typical mold found on inside of windows, a result of condensation from leaky interior storm windows.*

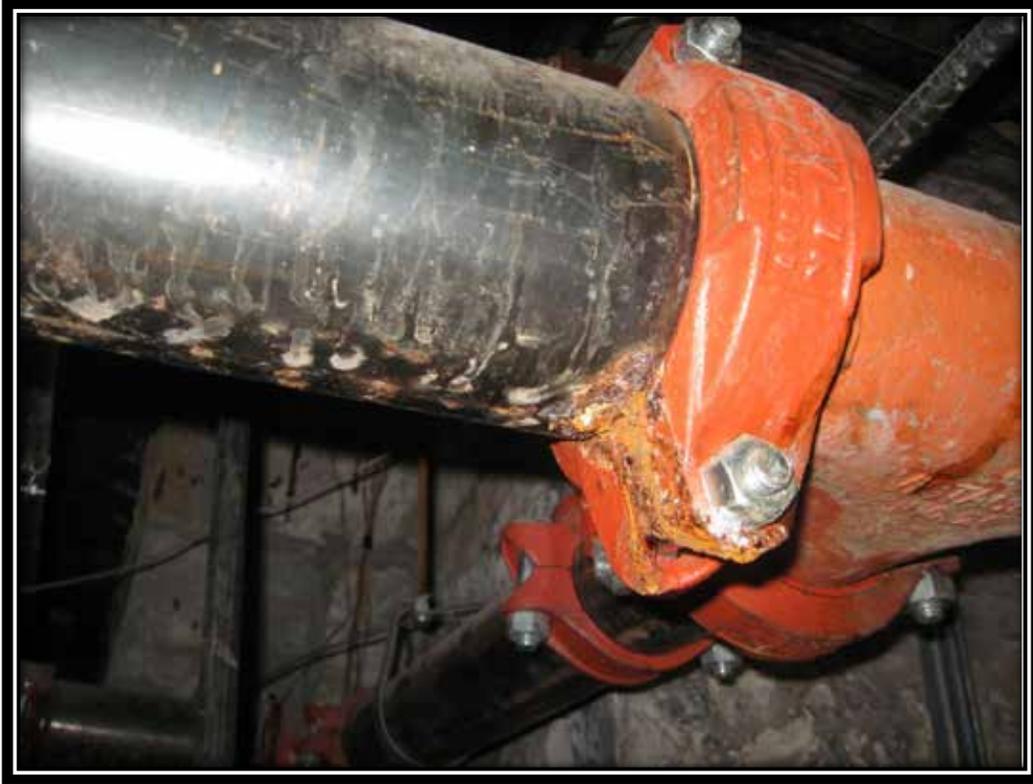
*This image shows typical Hermitage mansion sprinkler pipe corrosion at a rolled joint.*

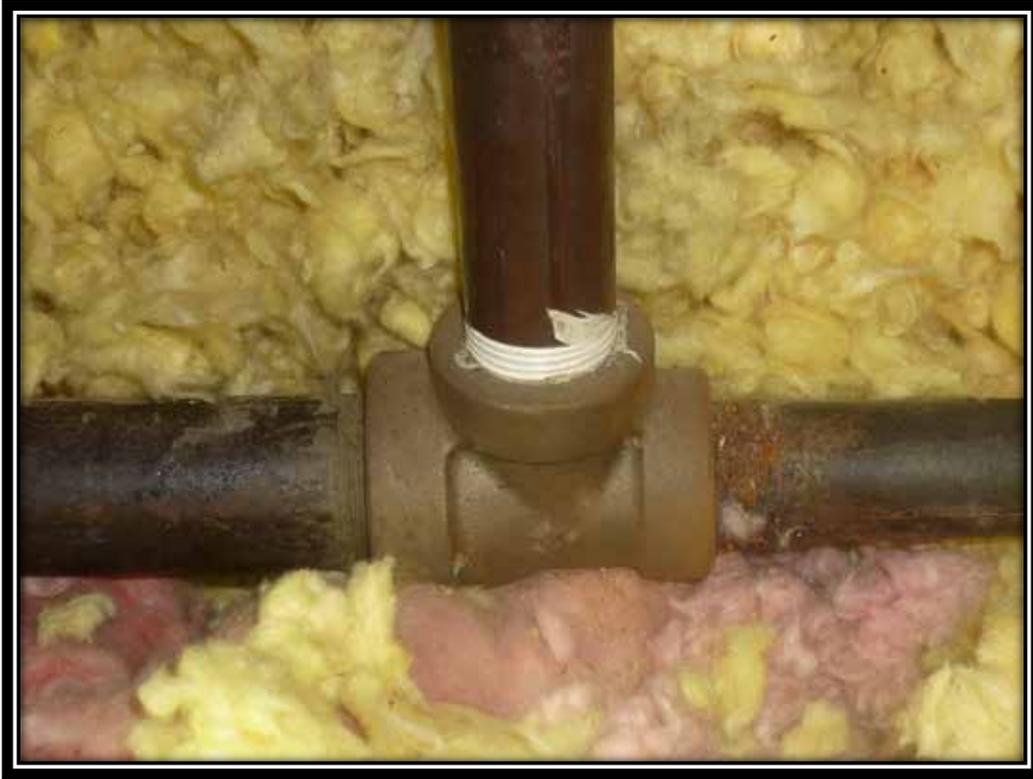
*Typical Hermitage mansion sprinkler pipe corrosion at threaded fittings.*

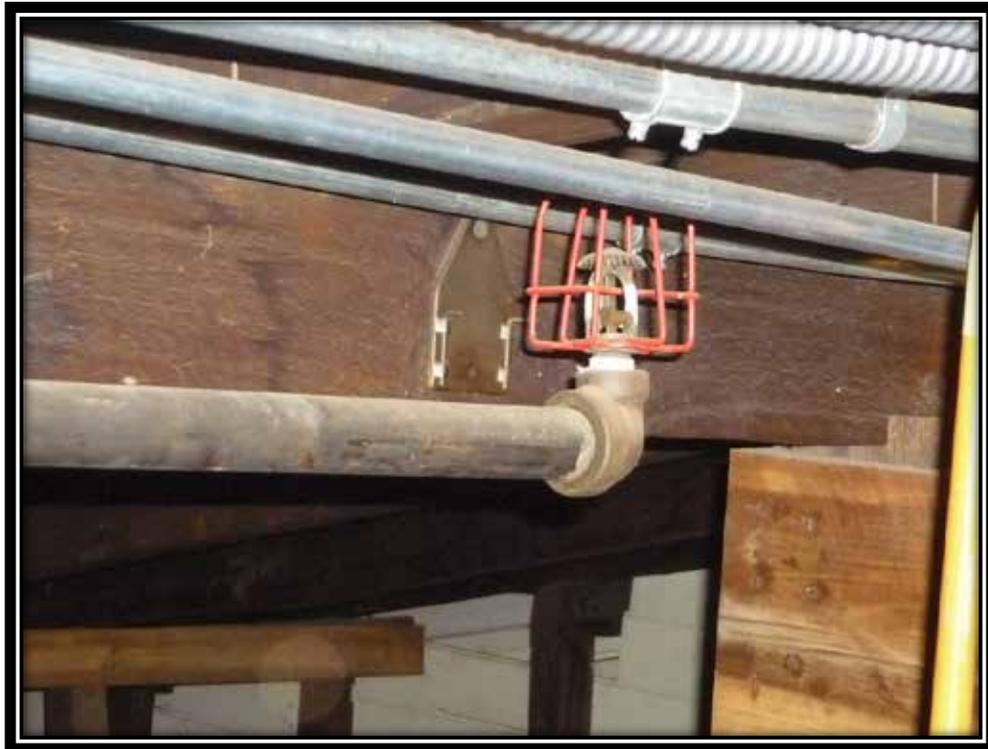
*Typical obstructed sprinkler head in the Hermitage mansion attic.*

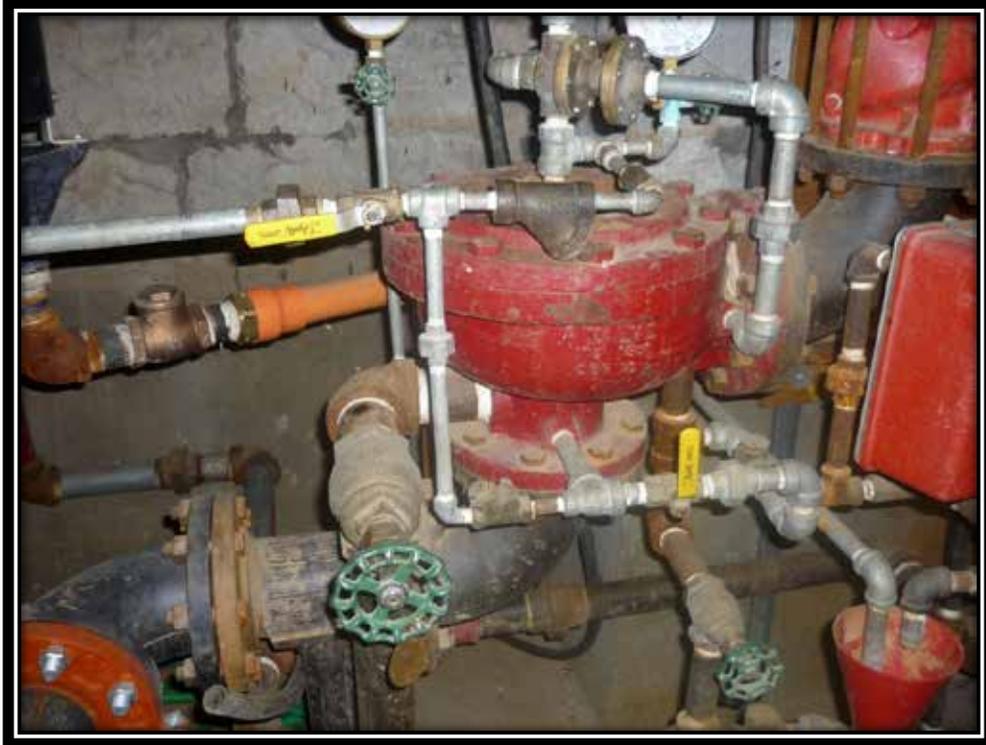
*This image shows the 25 year-old deluge valve in the basement of the Hermitage mansion which LFG recommends be replaced.*

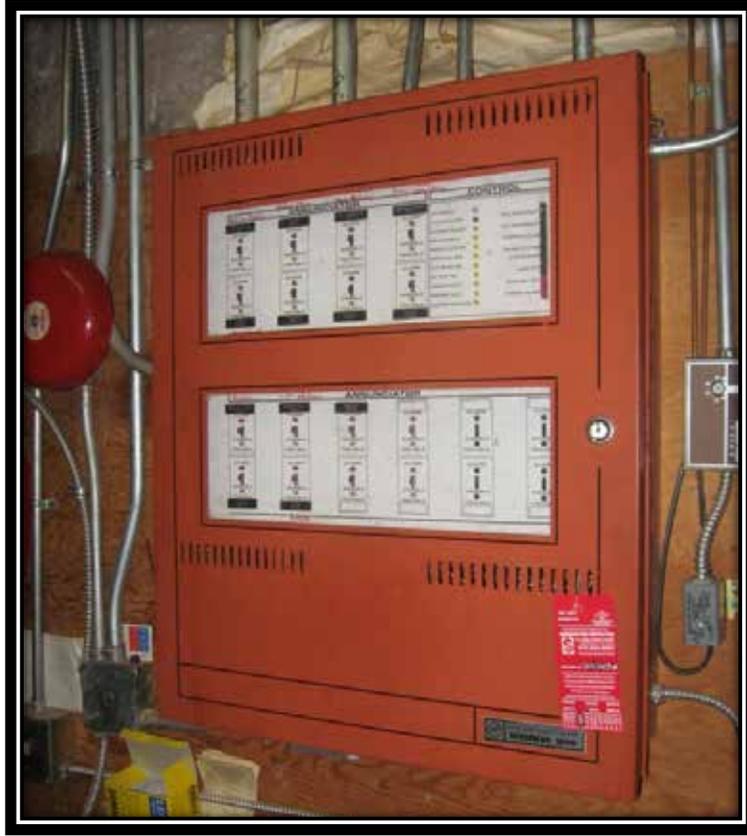
*1988 Fire Alarm Control Panel in the Hermitage Basement.*

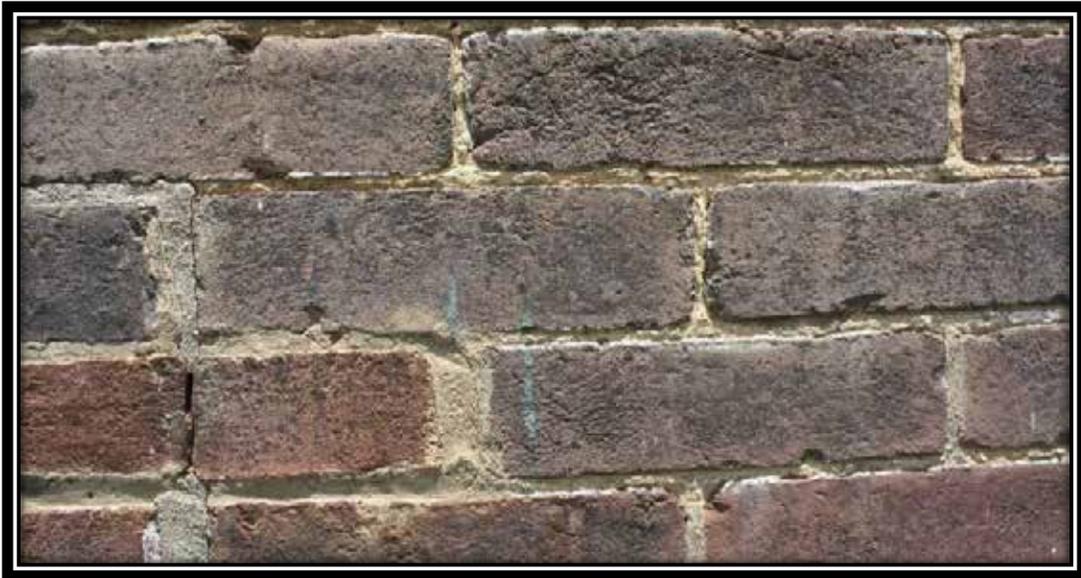
*A previous repointing effort at Tulip Grove was not installed deeply enough into the joint. That repointing mortar failed and took off the face of the historic lime sand mortar underneath it. Tulip Grove requires complete repointing on all elevations, May 2010.*

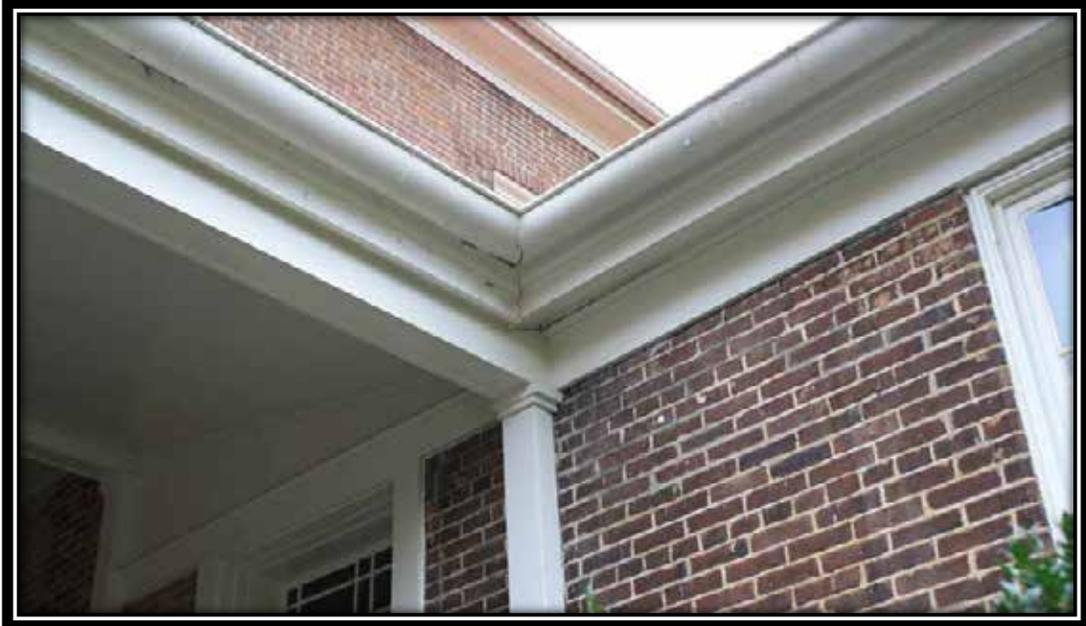
*Failed mitered corners in Tulip Grove's gutter system have resulted in wood deterioration underneath, May 2010.*

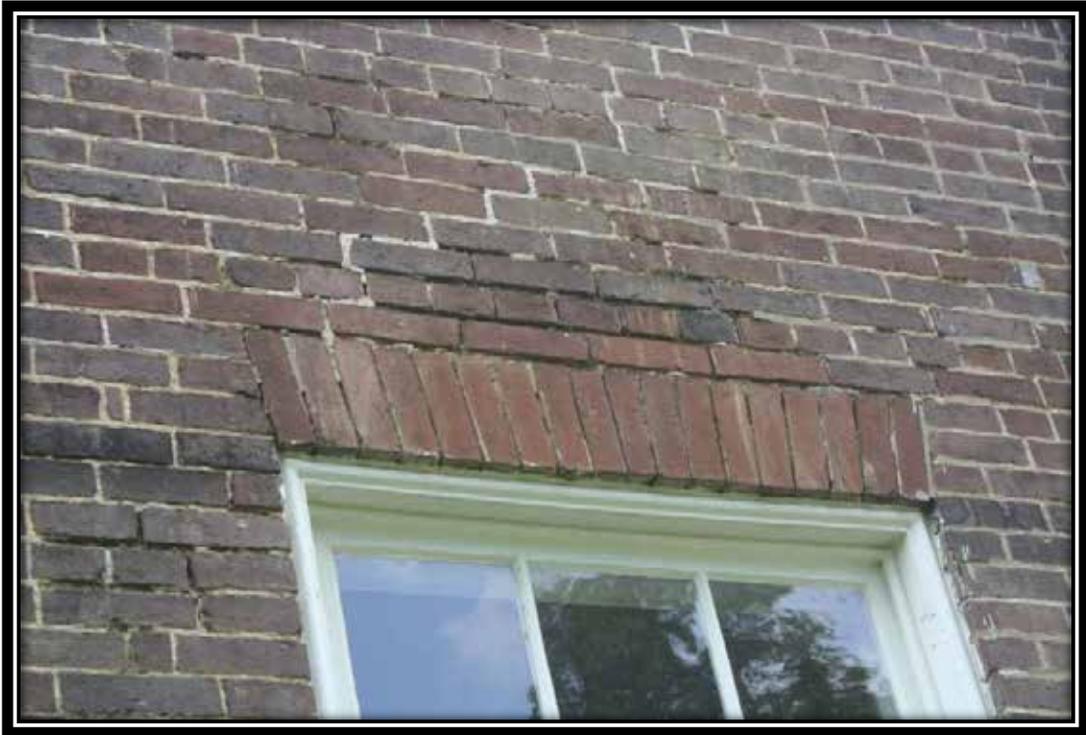
*Typical mortar joint deterioration over window jack arches.*

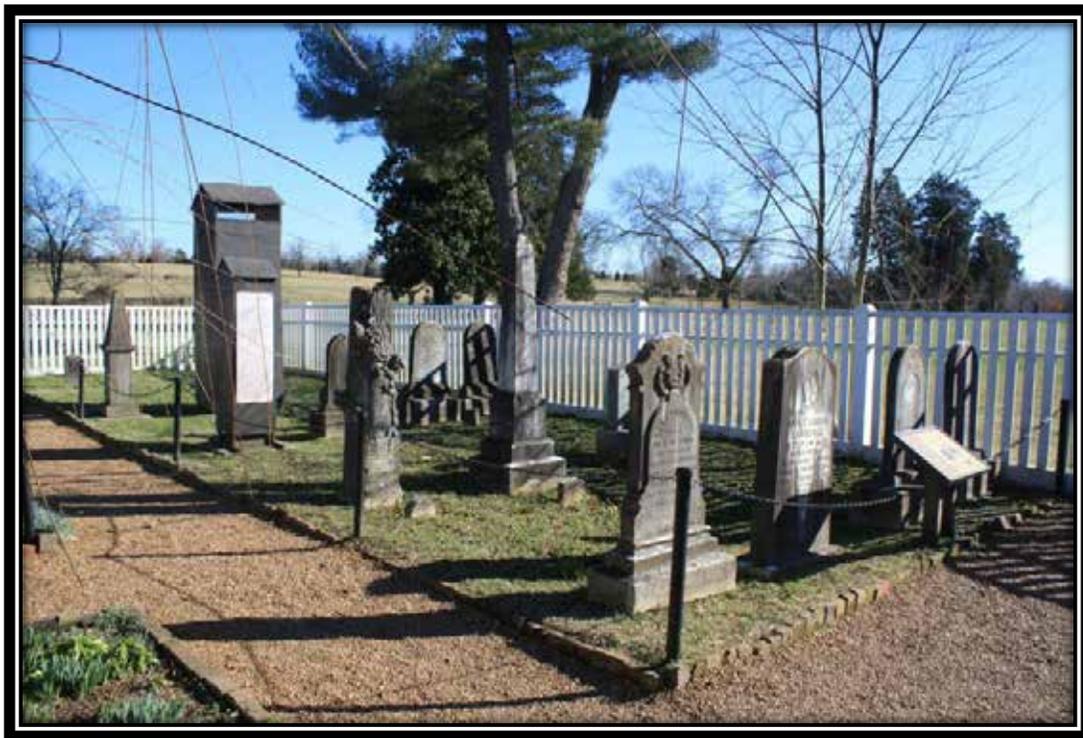
In general, the gravestones in the Jackson and Donelson Family Cemeteries are in fair condition. All require cleaning to remove pollution and biological deposits. The Jackson Family Cemetery requires significant soil backfill to correct soil subsidence likely caused by collapse of caskets and rotting tree roots. In addition, the shared gravestone of Andrew Jackson Jr. and his wife Sarah and the gravestone of Jackson family friend and portraitist Ralph E.W. Earl need immediate attention. Both gravestones are made of limestone and the limestone layers are delaminating. It is very likely that portions of both of these will require replacement. In the Donelson Family Cemetery, the vault style memorials for Captain John and Mary Purnell Donelson are unstable because of cracks in the stones.

*Overall image of the Jackson Family Cemetery showing darkening of stones from airborne pollutants and biological growth. The two gravestones in wood boxes are those of Sarah and Andrew Jackson, Jr. and Ralph E.W. Earl.*

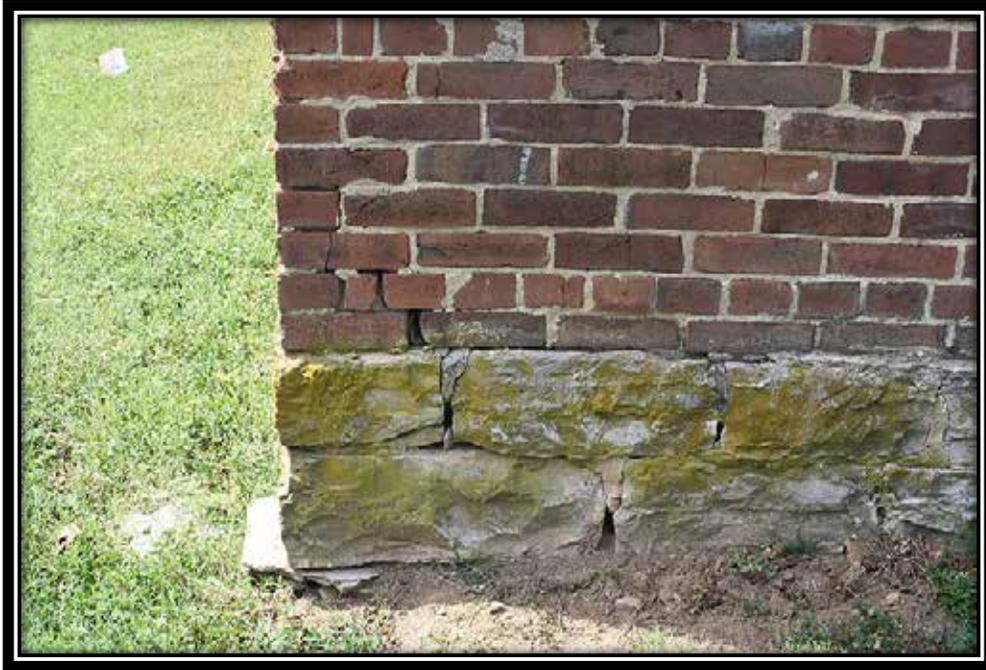
Overall the Hermitage Church is in sound condition, but repairs are needed to maintain the building's exterior shell. First and foremost, the foundation requires repointing as soon as funds are available. The brick walls exhibit mortar deterioration, especially around windows and doors. The building's shingle roof exhibits significant deterioration and must be replaced within the next two years. The estimated cost of this work is \$85,000. This project is not funded at this time. Hermitage staff is actively seeking grant opportunities and private donations to complete this work.

*This image shows failed mortar in the Hermitage Church foundation and walls, May 2010.*

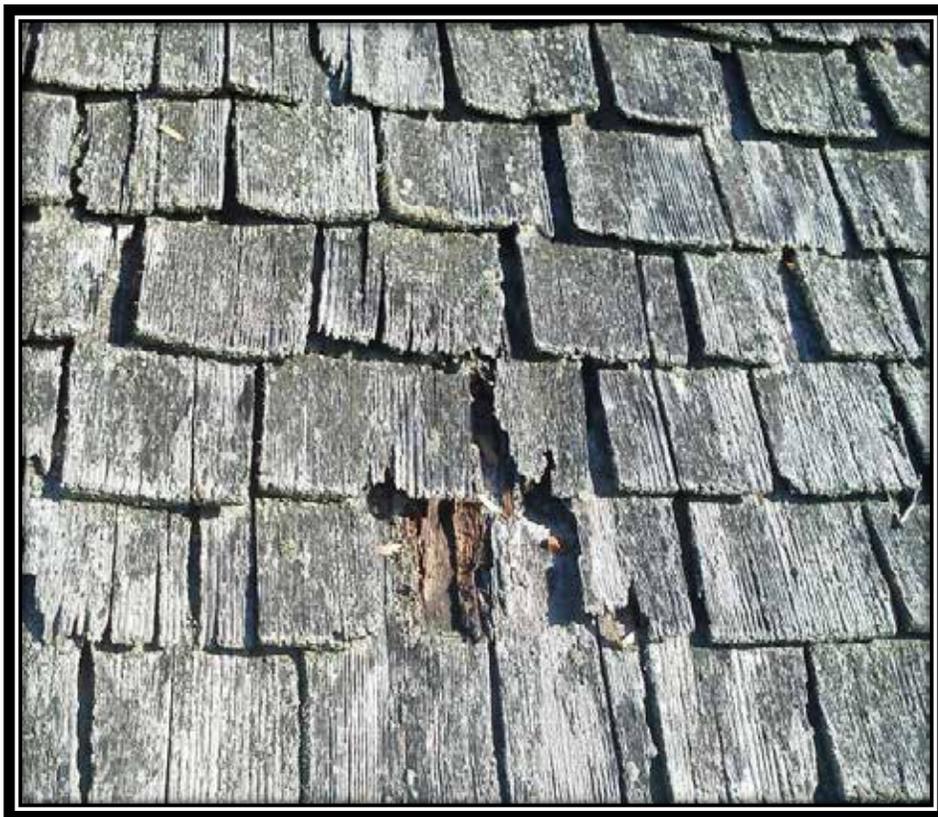
*Typical condition of church roof shingles. Note split shingles and large gaps in coverage.*

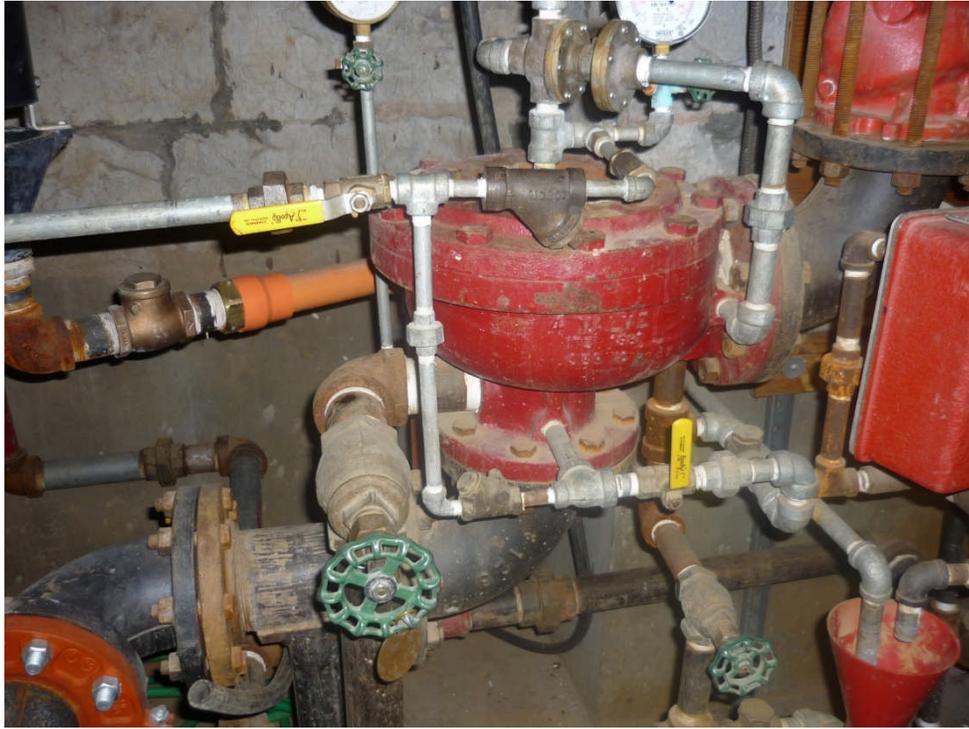
**Figure FS-7: Deluge Valve Used for Single Interlock Pre-Action System**

1. **Continue Use of Pre-Action System:** Since a pre-action system provides protection from accidental water discharge, it is recommended that a pre-action system continue to be used in the Mansion. The deluge valve is 25 years old and should be replaced as part of the next system upgrade to ensure longevity and long term component availability for future maintenance.

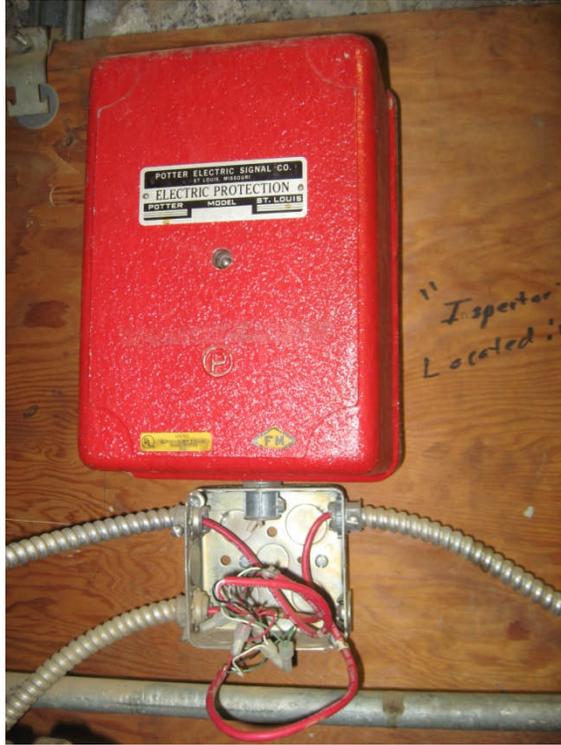
A pre-action system is normally filled with compressed air which is used to monitor pipe integrity, as leaking pipes would cause a loss in air pressure that would be sensed by a pressure monitoring switch. A loss in air pressure would send an alarm through the fire alarm panel; however, the low pressure alarm switch has been disconnected (Figure FS-9). It has been reported by the Hermitage staff that the low pressure alarm switch has been repaired since the October 2013 survey.

Figure FS-9: Low Pressure Alarm Switch on Pre-Action System has Been Disconnected

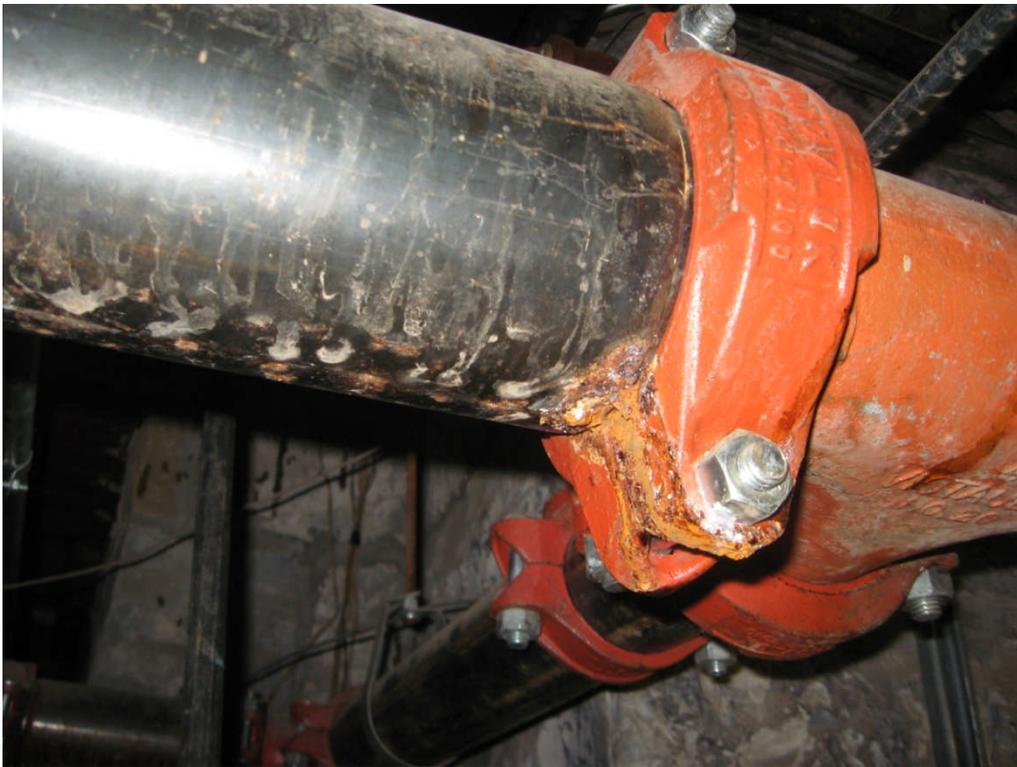
A concern for owners of pre-action systems is premature failure of the pipes from corrosion. The compressed air used for monitoring introduces moisture into the system and there is always residual water in the pipes from previous flow tests. The compressed air provides a new supply of oxygen each time the compressor runs, which accelerates corrosion where water has accumulated; usually at low pockets and at rolled grooved fittings. Rusted fittings were observed at several locations in the basement and attic (Figure FS-10A & 10B and FS-11A & 11B).

Figure FS-10A: Rusted Rolled Fitting in Basement

4. **Replace All Sprinkler Pipe:** It is recommended that the sprinkler piping be replaced throughout the building. The extent of the pipe corrosion is impossible to quantify by an

external inspection, and corrosion in a pre-action system is not uniform. This means that if a detailed corrosion investigation is performed at a number of locations, the results may not be representative of the entire piping system. Given the age of the system and the corrosion that was found at several fittings, a complete replacement will provide the best assurance against a pipe failure. It is also recommended that schedule 40 pipe be used throughout to extend the life of the system by providing thicker wall pipe.

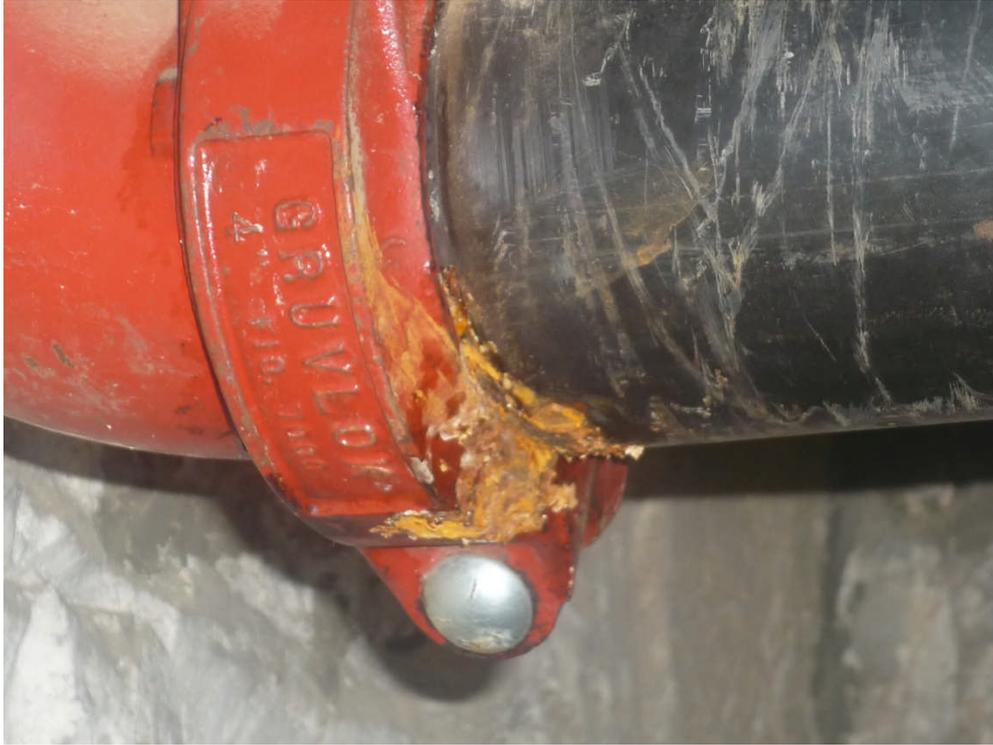
NFPA 13-2007, “Standard for the Installation of Sprinkler Systems”, requires the piping for a pre-action system to be installed so that it can be drained. Pipe mains must be pitched at least ¼ inch per 10 feet and branch lines must be pitched at least ½ inch per 10 feet. Earlier editions of the code did not require the pipe to be pitched in areas not subject to freezing. It was observed that some of the piping in the attic was not sloped, which can allow puddles of water to develop inside the pipe, which accelerates corrosion. Water tends to collect at rolled grooved fittings and screwed fittings, especially if the pipe has not been reamed. Rusted fittings were observed at several locations in the attic which may be due to inadequate sloping and drainage of the piping system (Figure FS-11A & 11B). Additionally, rusted fittings were observed at the service entrance in the basement where the pipe is back sloped (Figure FS-10B).

**Figure FS-10B: Rusted Rolled Fitting in Basement**

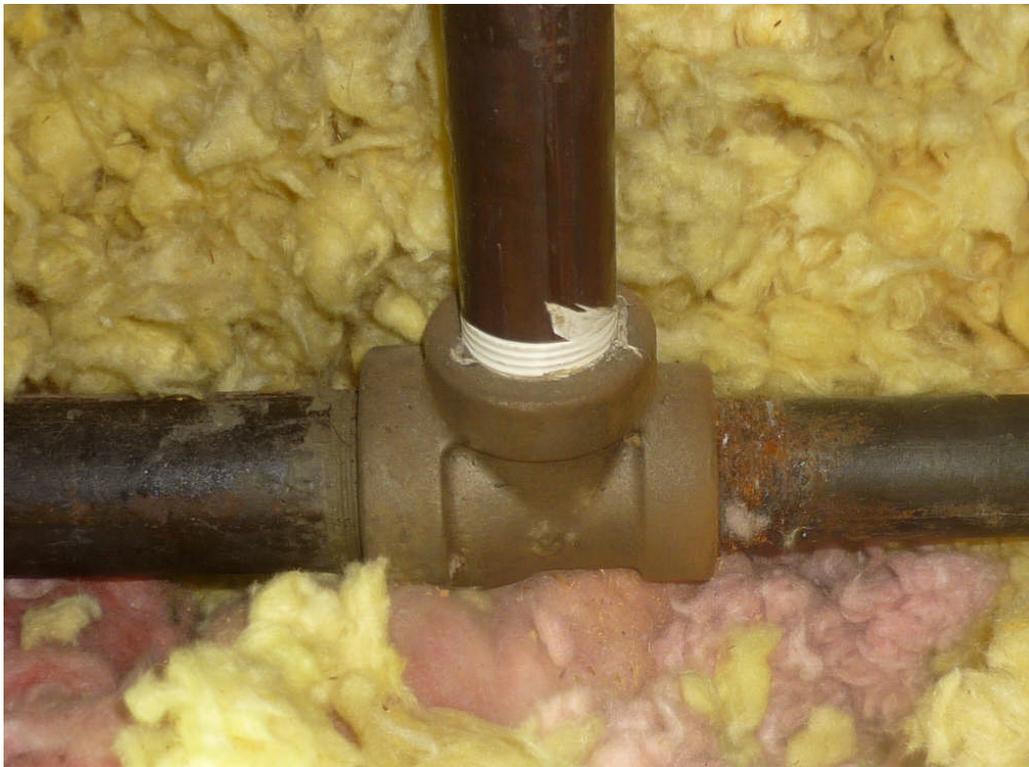
**Figure FS-11A: Rusted Threaded Fitting in Attic**

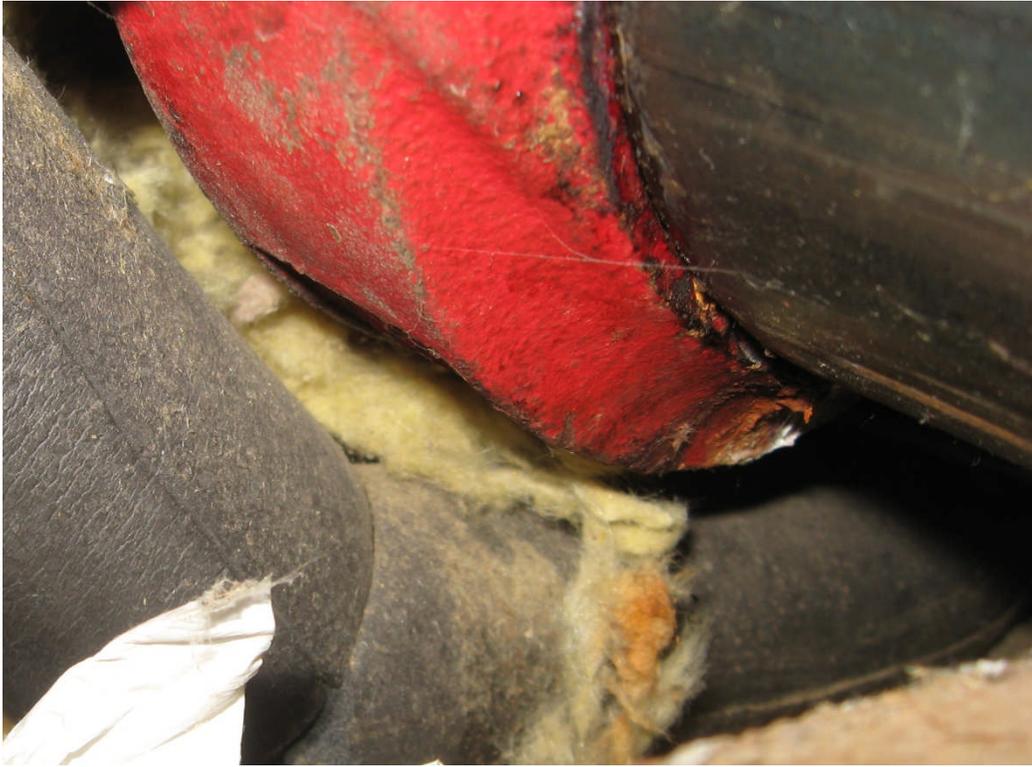
Figure FS-11B: Rusted Rolled Fitting in Attic

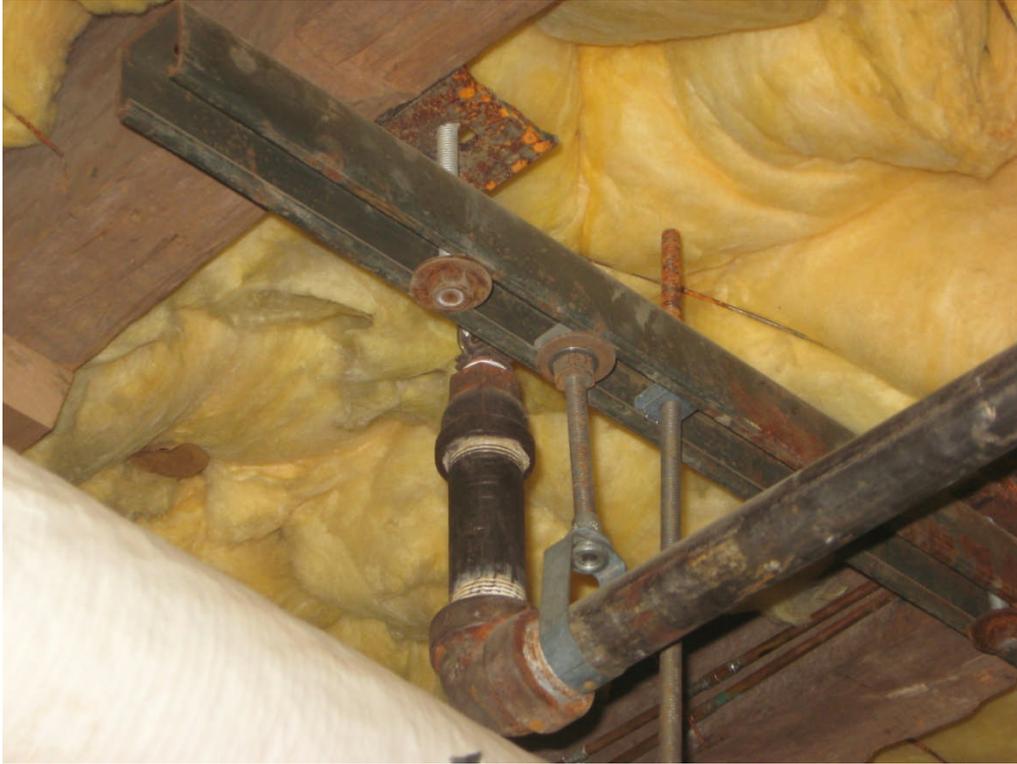
A number of sprinklers will have the water spray obstructed by a variety of objects including structural members, ductwork, hangers and insulation (Figure FS-15A to FS-15D). The code allows a few types of obstructions to sprinkler spray patterns in light hazard occupancies, but in most cases sprinklers are required to be installed in locations where the spray pattern can be fully developed. When this is not possible additional sprinklers must be installed.

**Figure 15A: Sprinkler Spray Obstructed by Pipe Hanger in Basement**

3. **Correct Sprinklers with Obstructed Spray:** It is recommended that sprinklers with obstructed spray patterns be relocated or additional sprinklers be installed to ensure adequate coverage.

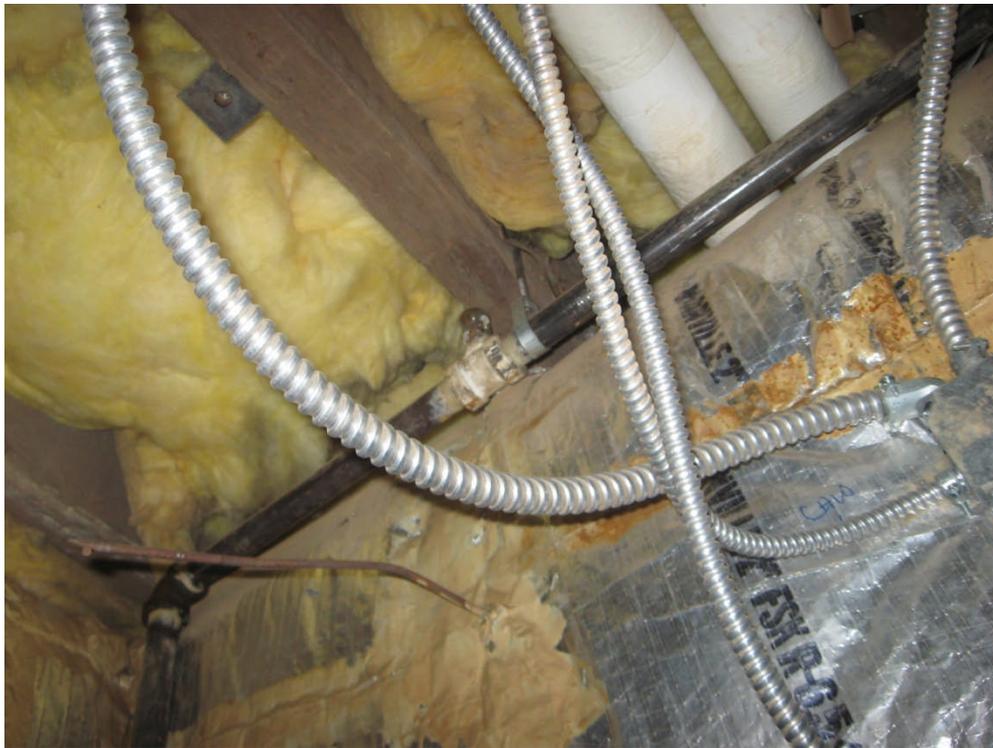
**Figure 15B: Sprinkler Spray Obstructed by Duct in Basement**

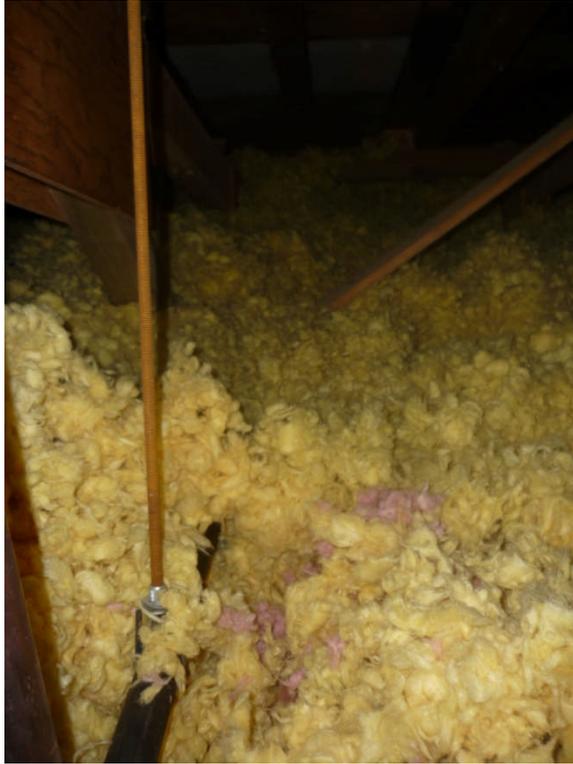
Figure 15C: Upright Sprinkler Spray Obstructed by Insulation in Attic

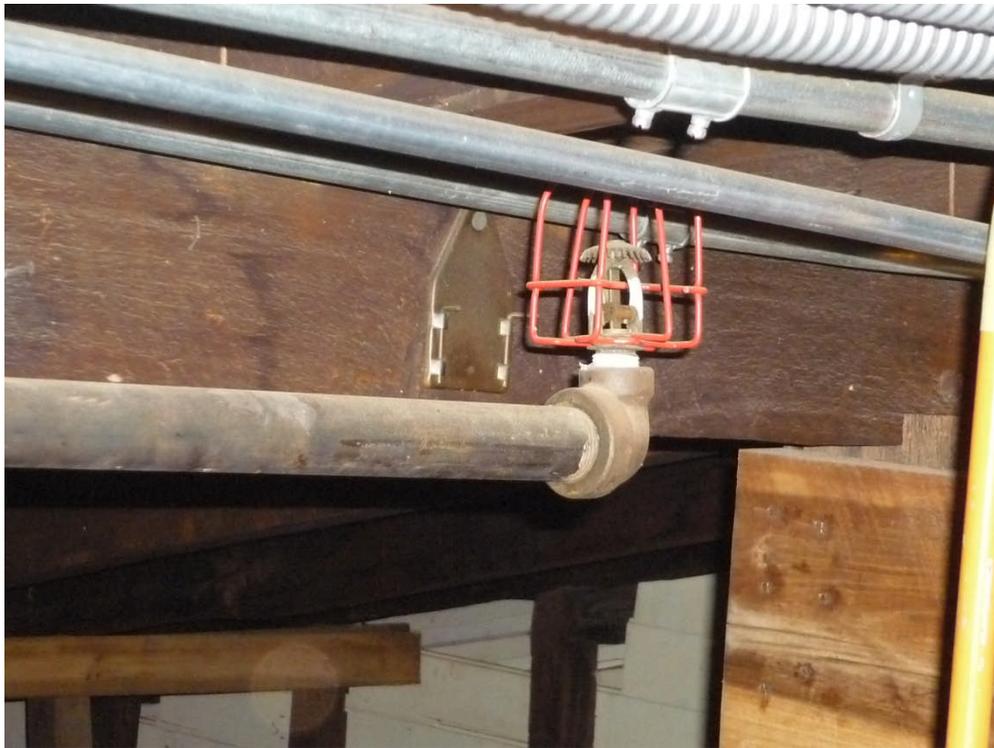
Figure 15D: Upright Sprinkler Spray Obstructed by Beam in Attic

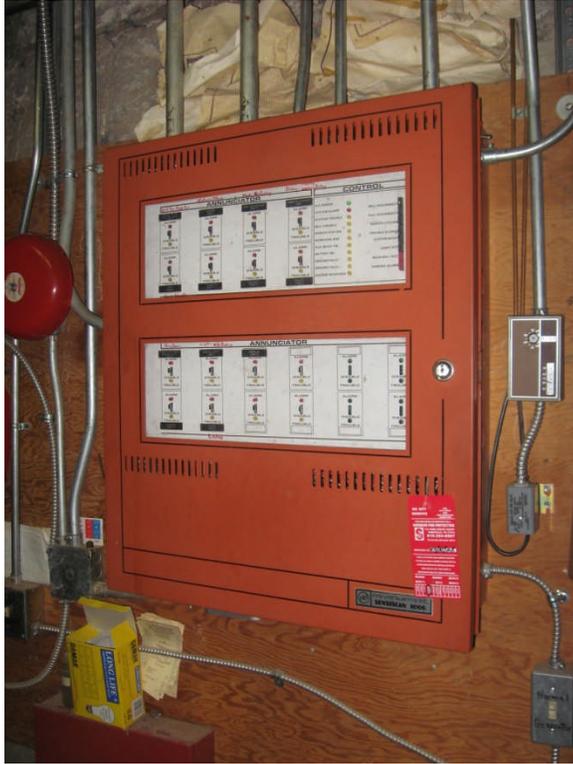
The Sensiscan 1000 FACP is no longer manufactured or supported by Fire Lite since 2006. Therefore, if it should become necessary to repair this panel, remanufactured parts from third party vendors would have to be used. A panel of this age that is no longer supported by the manufacturer should be considered for replacement with either another conventional zoned panel or an addressable panel.

Figure FA-1: Sensiscan 1000 FACP is 25 Years Old

1. **Install New Addressable Fire Alarm Control Panel:** Since the existing FACP is 25 years old and is no longer supported by the manufacturer, it is recommended that it be replaced with a new panel. An addressable system has the advantage of narrowly identifying the location of a fire; therefore, it is the more preferable FACP to install over a conventional panel. The FACP must also be UL approved for use as a releasing device to activate the pre-action system.
