National Civil Rights Museum

Facility Assessment Report

SBC Project No. 529/000-16-1998

December 1, 2015

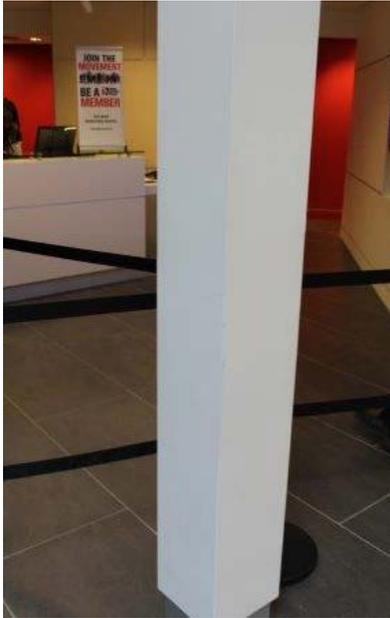
All public and exhibit areas have remained unchanged since the reopening in April 2014 and show areas of premature wear as a result of a to value engineering exercise during the pre-construction period which resulted in the elimination of impact resistant finishes. Column covers adjacent to the entrance admission's counter (Photograph 1), along with exterior corners of exhibit space require constant maintenance to maintain the desired finish.

Photograph 1 –
Damage to Column at Visitor
Entry

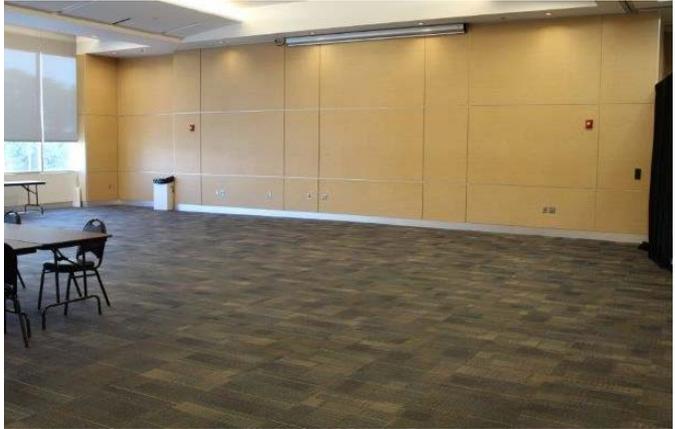
The event center continues to be a popular venue for programs and requires upkeep and maintenance. The original floor covering was replaced with carpet squares better suited for this use (Photograph 2). The use of the facility also necessitates better protection of the catering kitchen doors from food carts passing through (Photograph 3).

Photograph 2 –
Upgrades to interior of the event
space

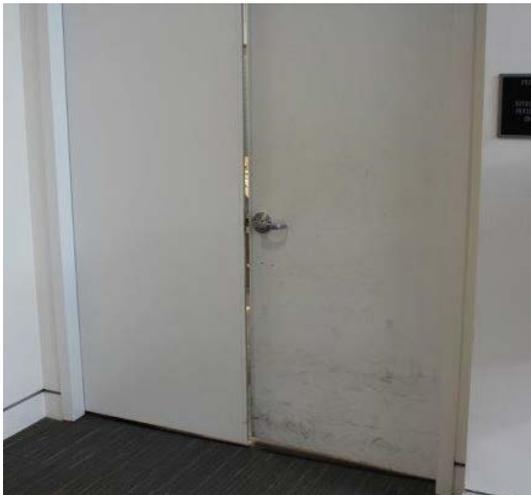
Photograph 3 –
Damage to door finish at catering
kitchen

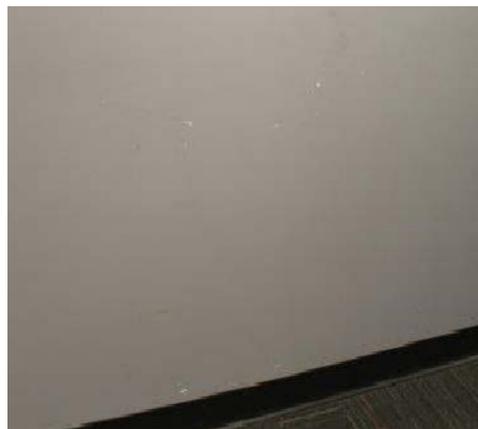
The Museum has incorporated an educational sector in the previous Loraine Hotel where school students have an opportunity to learn and participate in presentations as part of the school curriculum. The Educational Center has several “classroom” spaces along with a resource library. Due to its constant use, some areas are showing signs of disrepair requiring attention to safeguarding wall surfaces (Photograph 4).

Photograph 4 –
Damage to wall at education
center

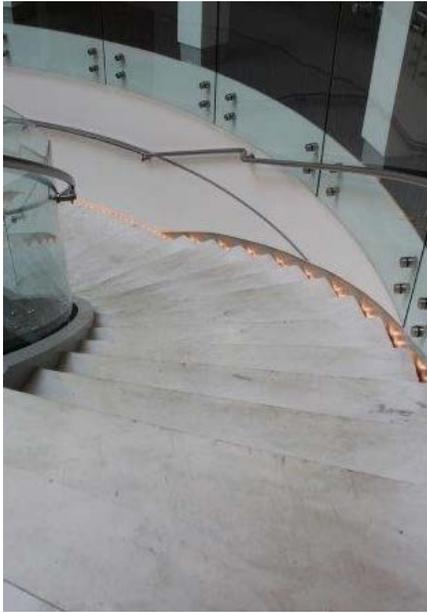
Public areas show usage patterns where ongoing maintenance will be required to maintain the proper level of finish and presentation for the Museum. The main lobby stair presents a unique situation where the initial non-slip finish, required by local codes, shows significant signs of traffic patterns while customary housekeeping services cannot maintain the stair’s original appearance (Photograph 5).

Photograph 5 –
Non-slip finish retention of dirt

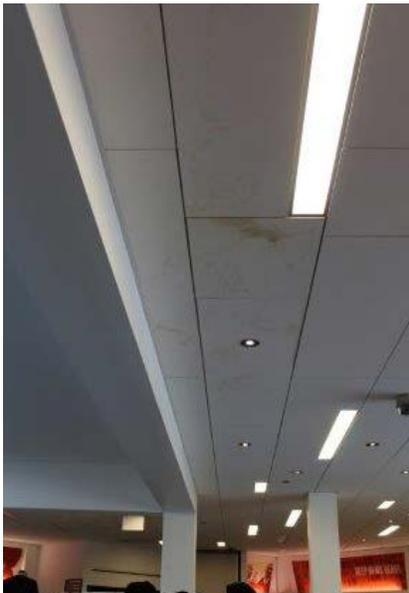
The Lobby Gift Shop (Photograph 6) continues to be an attraction as well as a revenue generator for the Museum. Discolored ceiling tiles (Photograph 7) indicate roof leak issues that have been ongoing since the reopening. The previous 2014 assessment indicates issues with flashing and the actual roof drain during events of heavy rain.

Photograph 7 –
Damaged ceiling tile at Gift
Shop

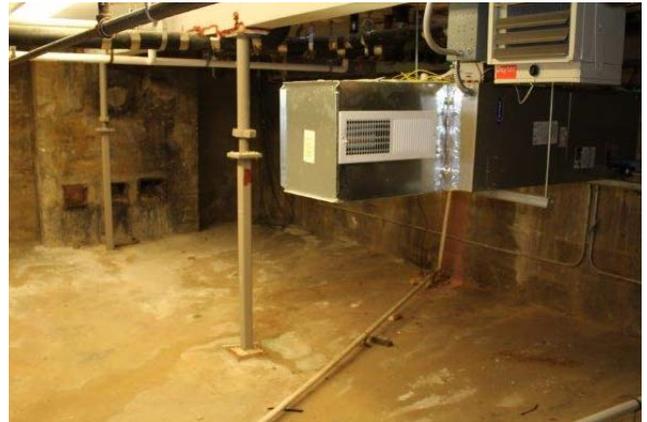
The basement area was improved with additional ventilation, mitigation of mold, and installation of hard finishes (Photographs 8). The basement/equipment room was repaired and remains dry and operational with numerous pieces of ventilation equipment critical to the Museum’s operations (Photograph 9).

Photograph 8 –
Ventilation unit at basement area

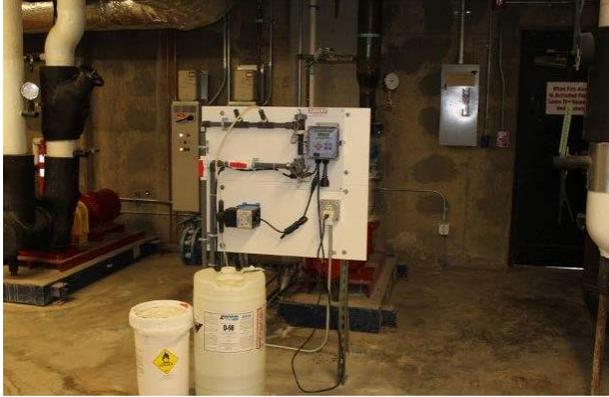
Photograph 9 –
Mechanical room improvements

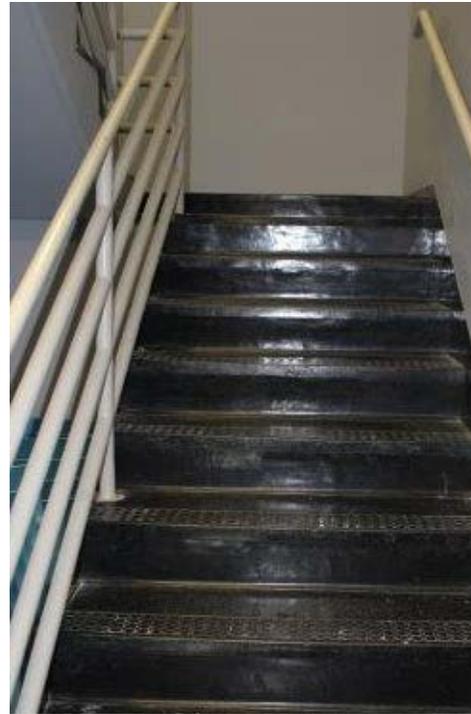
The stair, in the educational wing, reported in previous assessments has not been addressed and shows areas of disrepair (Photograph 10).

Photograph 10 –
Staff stair condition

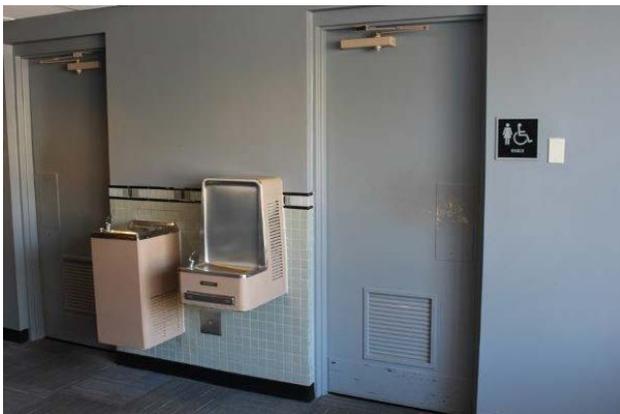
Restrooms associated with the display area will require finishes updating and improvement since they show signs of wear due to public use as noted on the previous assessment (Photograph 11).

Photograph 11 –
Public restroom condition in need of
upgrade

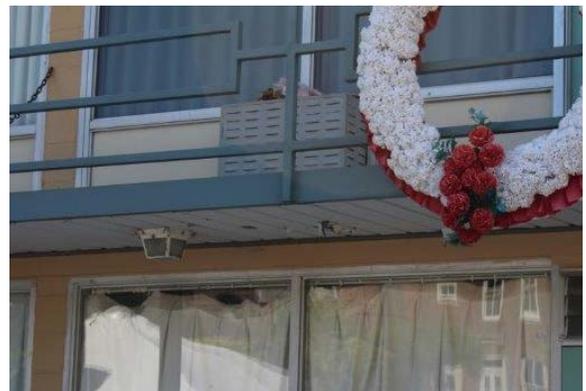
The exterior of the Lorraine Motel maintains its original presence and has restricted access for visitors since the reopening in 2014. Currently the balcony soffit shows signs of paint

deterioration and will require remedial work to maintain the appearance of the Museum while mitigating any further deterioration (Photograph 12).

Photograph 12 –
Exterior soffit paint deterioration

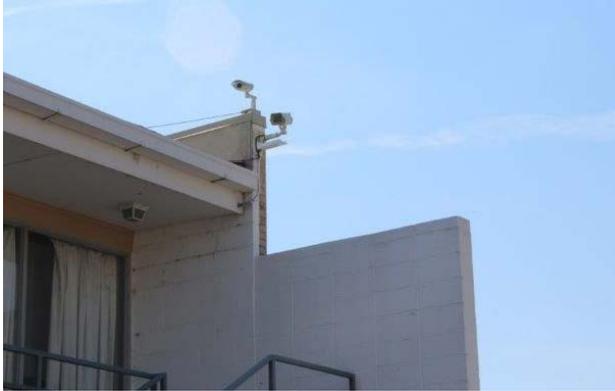
There is evidence of water migration at an intersection of the roof and a masonry wall (Photograph 13). The evidence of discoloration in the masonry joints should be investigated and mitigated by additional flashing or other suggested methods. Remedial work will avoid future serious issues and major repairs.

Photograph 13 –
Masonry deterioration due to
suspected water intrusion

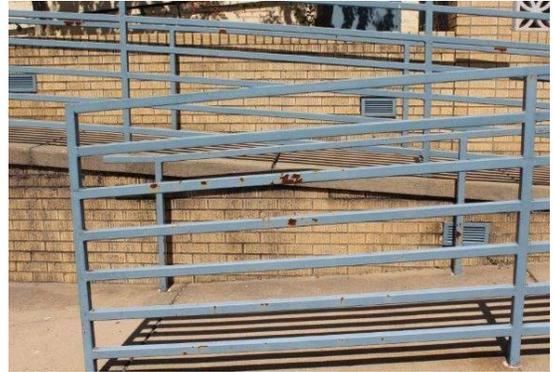
The staff entry, although improved, will require some detailed attention to finishes on metal and masonry surfaces. An adjacent area, housing mechanical equipment, subjects this entrance area to humidity and surface water compounding and accelerating the deterioration of finishes. This is evident by the deterioration of the railing that requires refinishing (Photograph 14).

Photograph 14 –
Railing coating deterioration

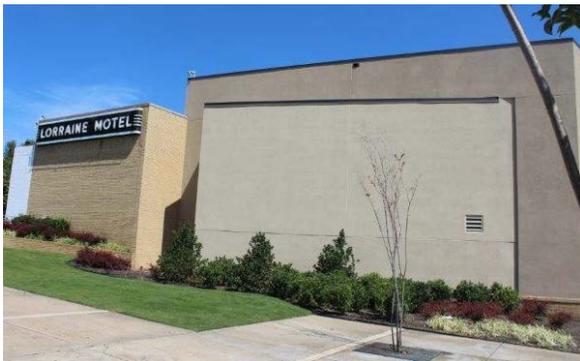
The exterior EIFS museum walls have been refinished and have been repaired which will avoid further problems with exterior wall failures as reported in the 2014 Assessment Report (Photograph 15).

Photograph 15 –
Exterior finish improvements

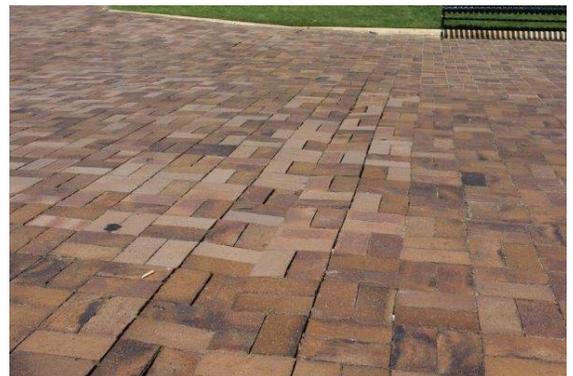
The plaza continues to be of concern since it is the walking surface for all visitors to the Museum. The brick paver system has undergone several repairs and replacements when the information kiosks were installed; however the majority of the paver units show evidence of disrepair presenting tripping hazards and uneven surfaces. A specific area shows evidence of substrate failure (Photograph 16), while a transition between the brick pavers and concrete walk present a significant issue for visitors with mobility issues (Photograph 17). The interface of dissimilar materials presents a challenge for expansion and joint treatment. The transition between the Mulberry Street curb and brick pavers continues to present challenges and tripping hazards for visitors from the parking area and the street. The interface of materials, compounded by the deterioration of the curb creates a hazardous situation for visitors (Photograph 18). The bullet trajectory indicator monument, previously a brick pattern, has been replaced with a more permanent granite material (Photograph 19).

Photograph 16 –
Brick paver plaza deterioration

The plaza will require a complete removal and reinstallation of the brick pavers in order to provide a safe walking surface and to repair some substrate problems. The current parking configuration and site access layout does not appear to address ADA requirements. Such accessibility requirements need to be addressed.

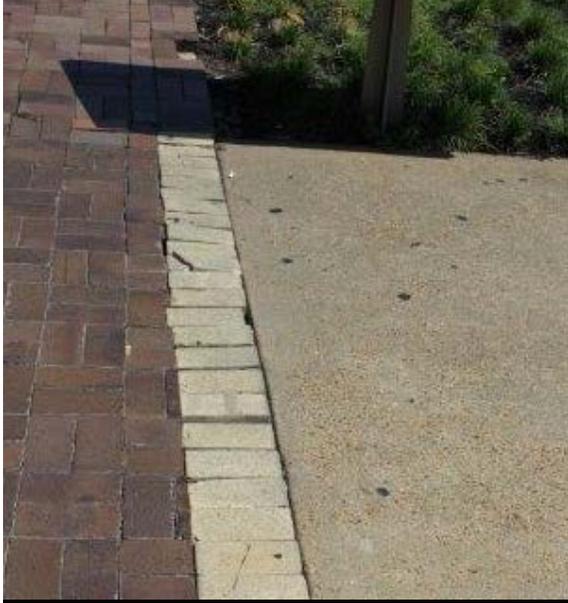
Photograph 17 –
Walk intersection deterioration

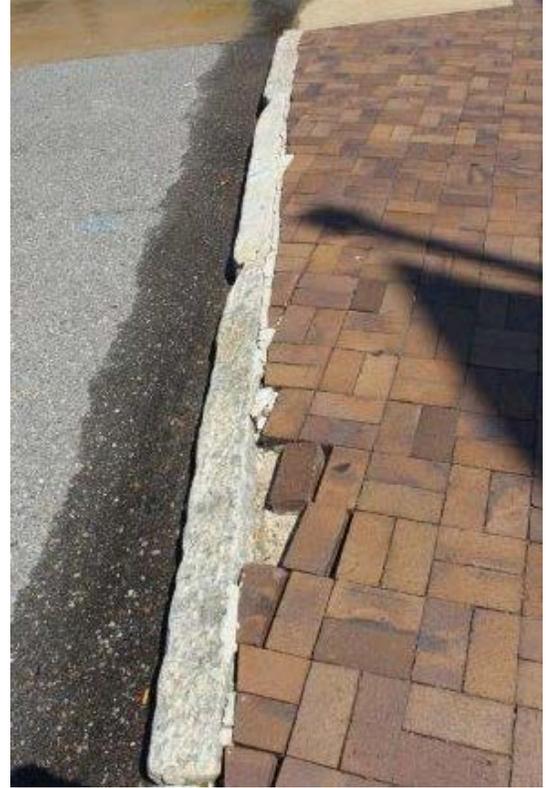
Photograph 18 –
Curb and brick paver walk interface
deterioration

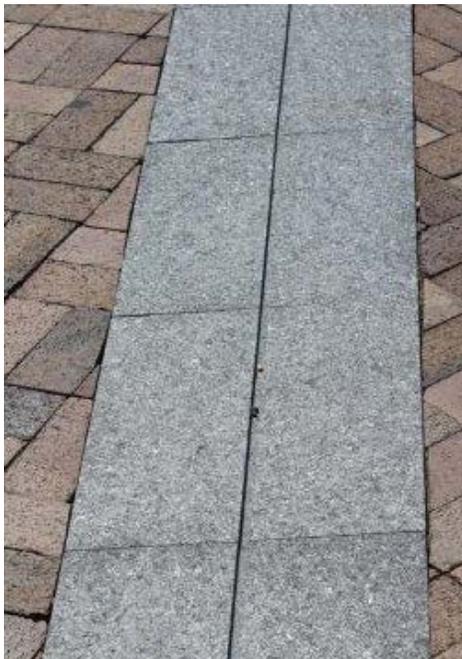
Photograph 19 –
Monument material modification
(Bullet Trajectory)
