#4: Struck by - 1043283

A **64 year old male** employee was fatally injured when he was struck in the head by the trolley system of an overhead crane. The crane, utilized to move aluminum coils into storage, is normally operated in automatic mode and controlled from a central control room. Due to new renovations of the coil storage area, the TR3-4 crane was not successfully programmed to operate in automatic mode. On the day of the accident, the victim was operating the TR3-4 crane in maintenance or manual mode. The victim was standing on an elevated platform or “open cab” connected to the crane. When the trolley is in the east most position, a metal bracket on the trolley, containing sensors that read load reflectors, passes the guardrail posts on the open cab within two inches. This hazard had been noted by the employer and “caution pinch point” stickers were placed on the guardrail posts notifying crane operators of the potential pinch point hazard. An employee on the ground was assisting the victim to place the coils on the storage racks through the use of hand signals, and verbal communication. The control panel on the open cab limited the victim’s line of sight, and he moved

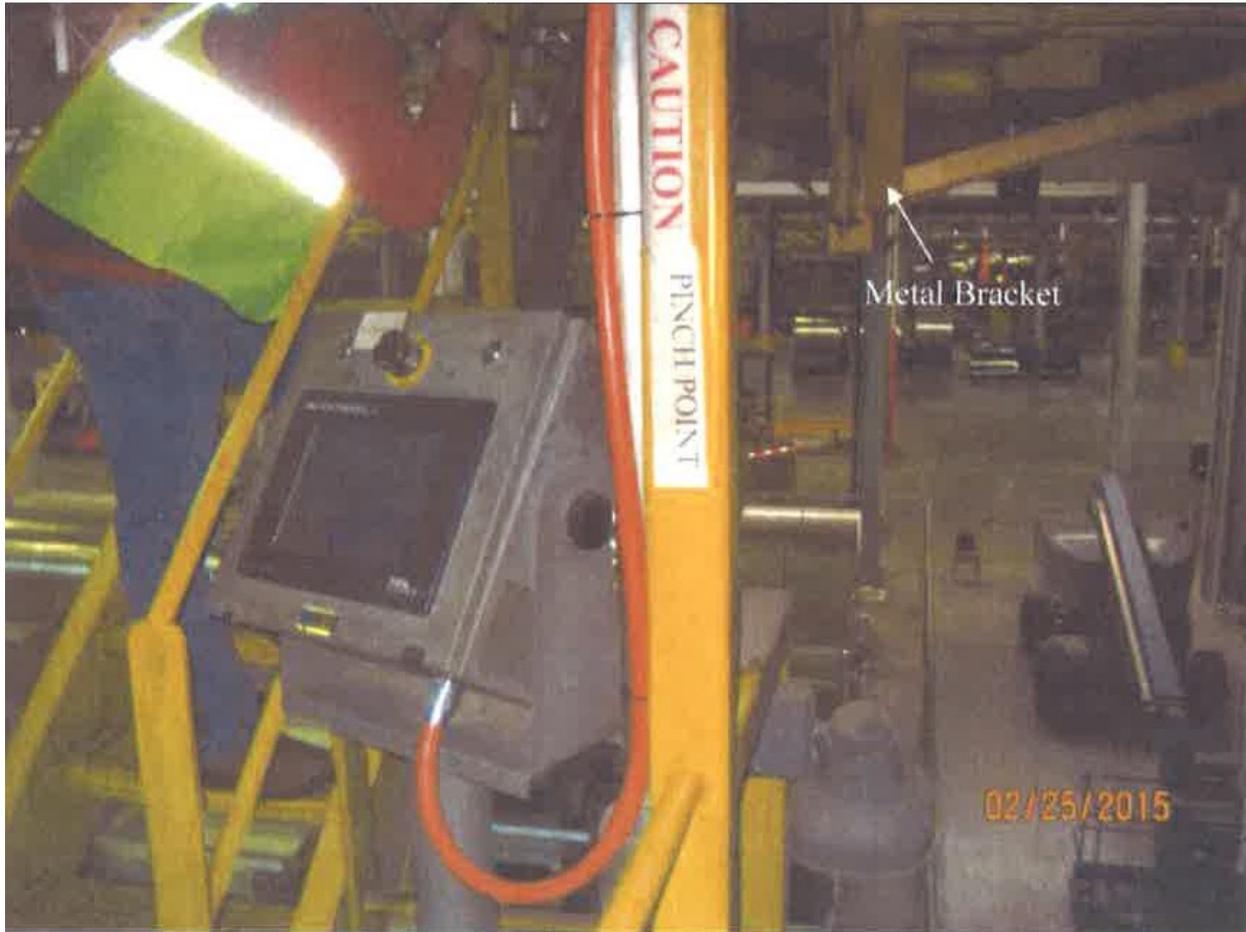
Photo 1 of 2 – This photo is a view of the platform where the open cab and panel are located for the crane.

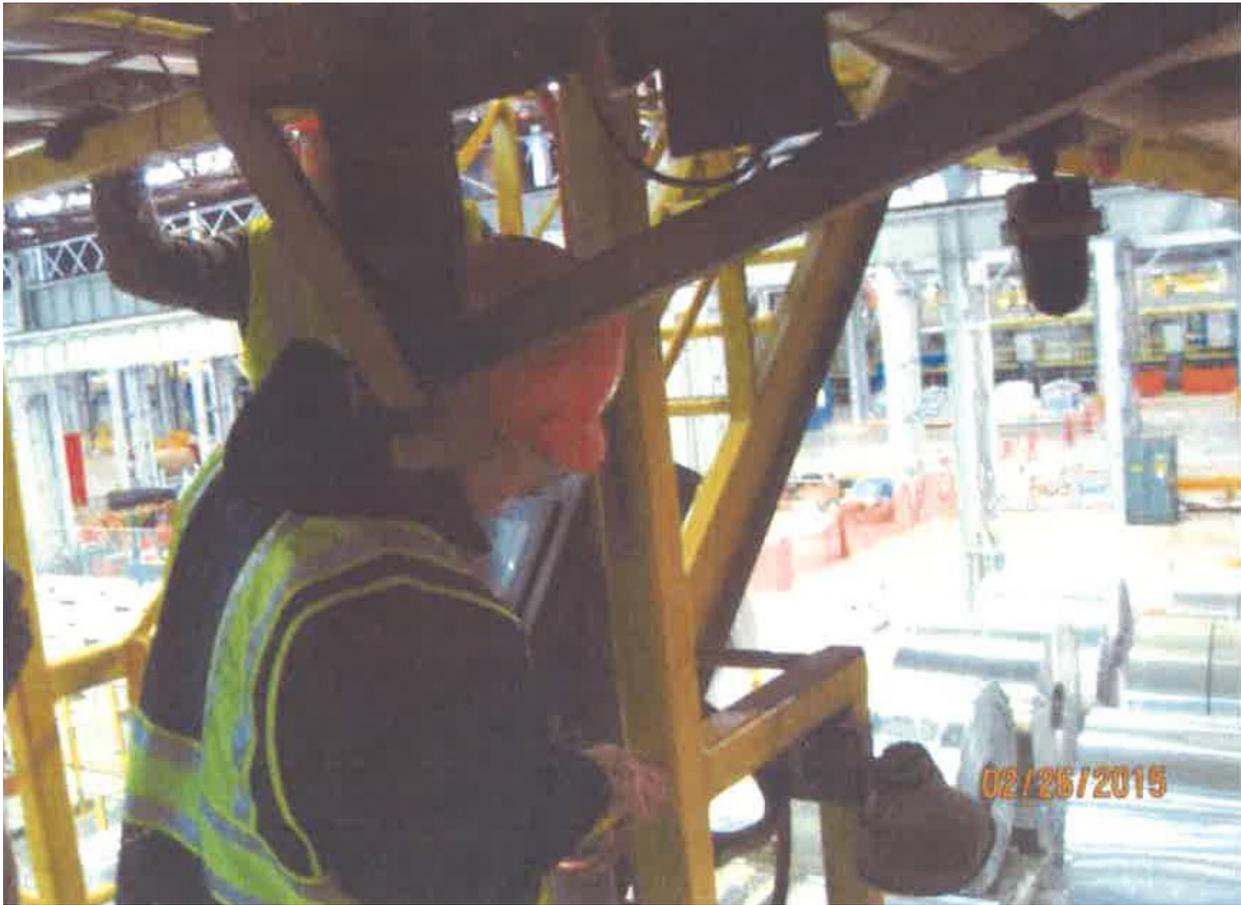
Photo 2 of 2 – This photo shows the where the victim was looking down into the storage area and the bracket on the trolley system.

TCA 50-3-105(1)	Each employer did not furnish to each of its employees conditions of employment and a place of employment free from recognized hazards that are causing or are likely to cause death or serious injury or harm to its employees. In that the crane operator was not protected from being struck by the crane’s trolley when manually operating the Hitachi 30 ton crane located in the east bay of building 816.
-----------------	--
