Thank you for your correspondence of September 30, 2005, regarding the Tennessee Department of Transportation's (TDOT) proposed Somerville Beltway State Route 15 (US Highway 64) Project (State Project Number 24092-1203-14) in Fayette County, Tennessee. TDOT proposes to construct approximately 13 miles of new highway around Somerville as shown on the attachments to your correspondence. Fish and Wildlife Service (Service) personnel have reviewed the information submitted and we offer the following comments.

FIGURES

PHOTOGRAPHS

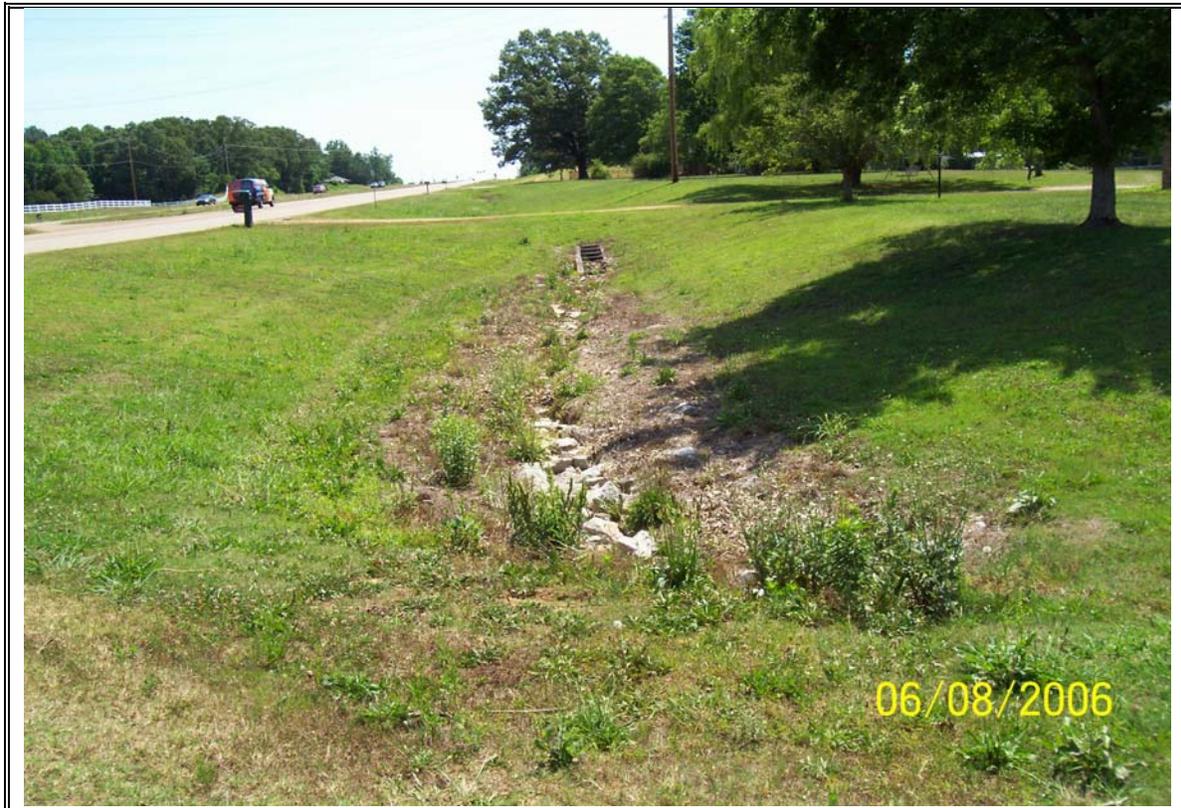
Stream watercourse waterbody	Project Segment	Location	Potential Impacts	Legal Designation (confirmed/unconfirmed)	Stream/Watercourse/Waterbody Description
WWC-1a	Section 1	STA 11+50 SR-460	Crossing	Wet weather conveyance	CBW: 1-3', TOB: 2-4', BH: 6"-2', Rip-rap, gravel, and soil substrate, No flow. Banks were moderately stable, 0% canopy coverage. No aquatic fauna observed.
WWC-1	Section 1	STA 15+00R Ramp 2	Runoff	Wet weather conveyance	Channel Bottom Width (CBW): 1-2', Top of Bank Width (TOB): 6-8', Bank Height (BH): 2-4', Soil Substrate, No flow. Banks were unstable, 90% canopy coverage – box elder, sweetgum, honey locust. No aquatic fauna observed.
WWC-2	Section 1	STA 18+00R Ramp 2	Fill	Wet weather conveyance	CBW: 1-2', TOB: 4-6', BH: 2-8', Soil substrate, No flow. Banks were unstable, 0-90% canopy coverage – box elder, sweetgum, sycamore. No aquatic fauna observed.
STR-1 Jones Creek	Section 1	STA 18+50R Ramp 2	Runoff	Perennial Stream	CBW: 30-40', TOB: 40', BH: 8-10', Soil and sand substrate, Water Depth (WD): 3"-1', Water width (WW): 10-35'. Banks were unstable, 0-25% canopy coverage –sycamore, black sherry, black locust, box elder, river birch. Water striders, caddisflies, aquatic worms, minnows and frogs were observed.

Photograph 1: Fayette County, WWC-1a facing upstream (east), no feature on USGS map; June 8, 2006.

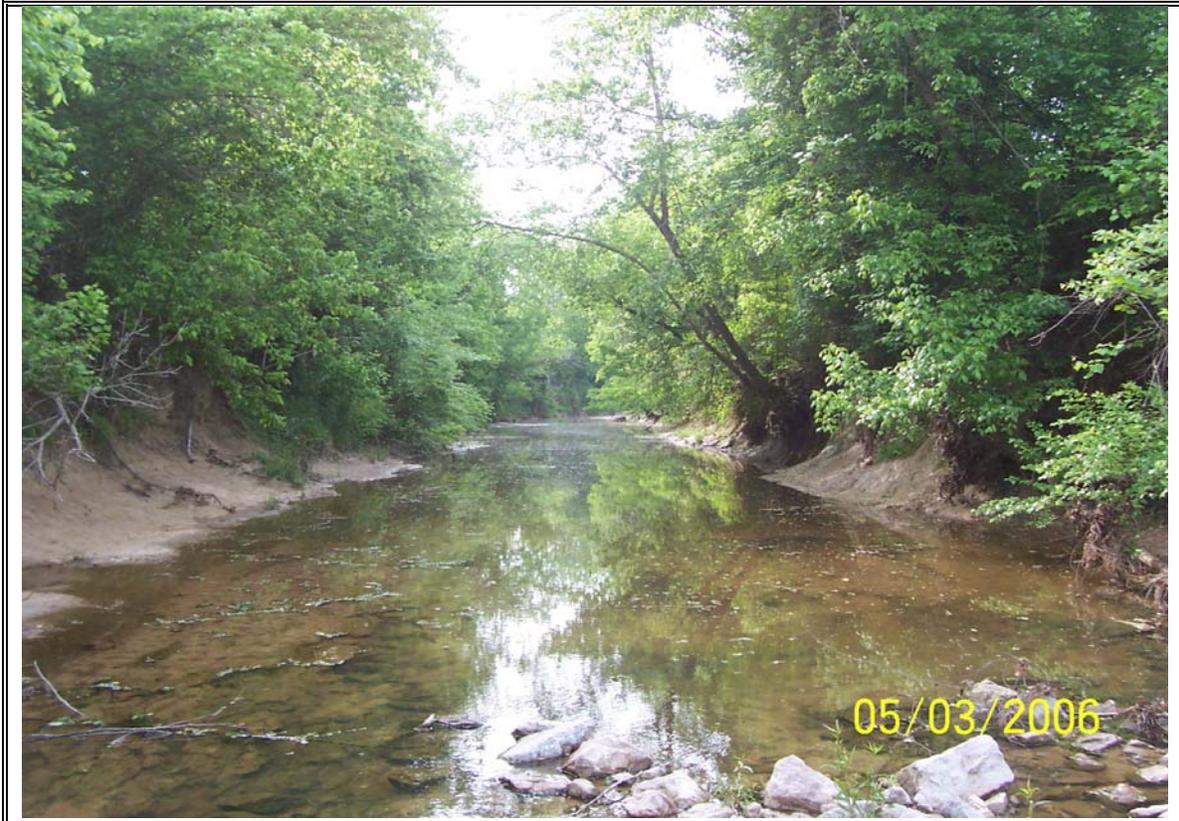
Photograph 3: Fayette County, STR-1 facing upstream (southeast), perennial on USGS map; May 3, 2006.

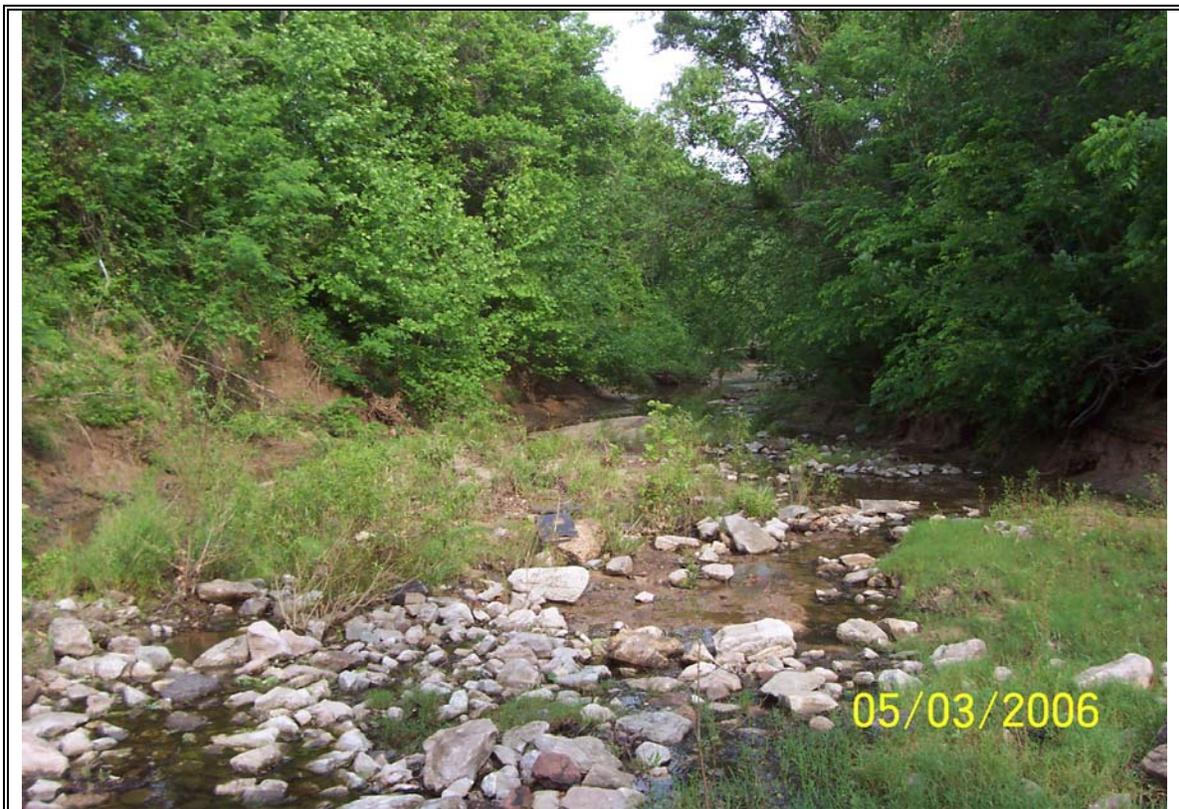
Photograph 4: Fayette County, STR-1 facing downstream (northwest), perennial on USGS map; May 3, 2006.

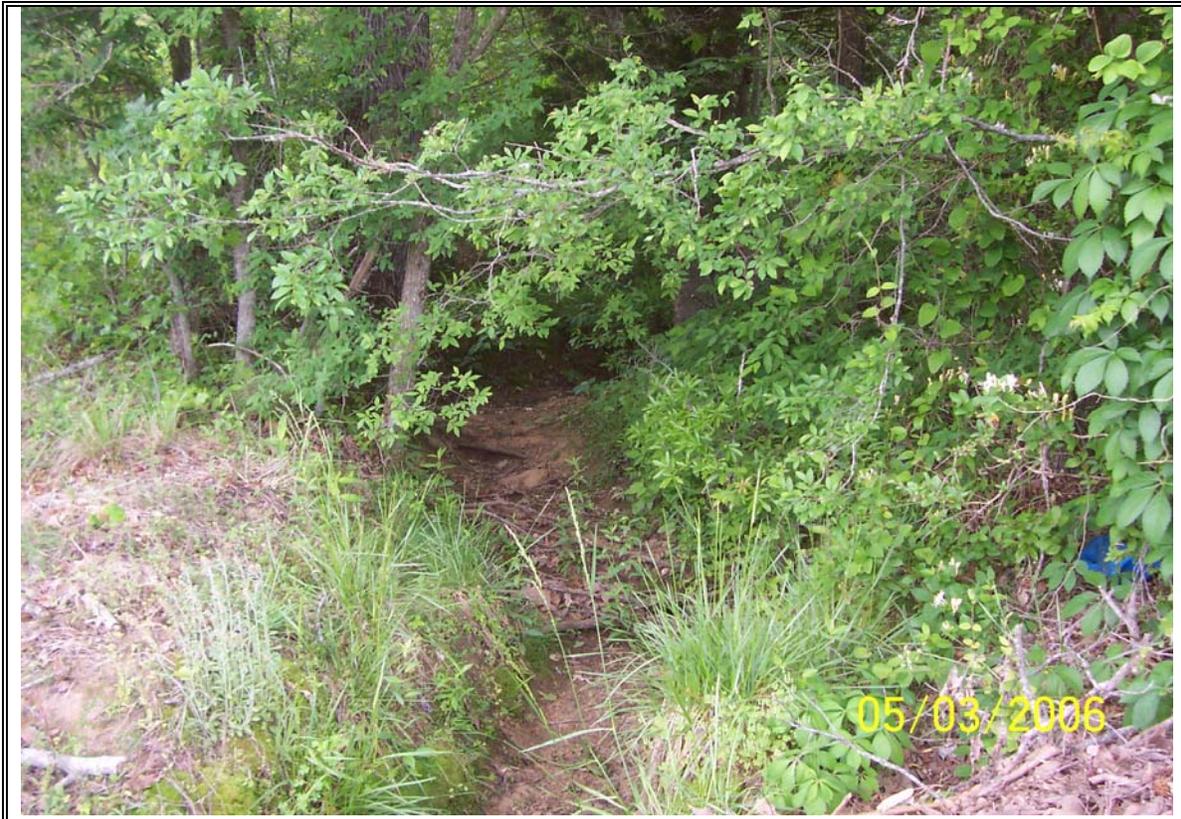
STR-2 Unnamed tributary to Jones Creek	Section 1	STA 22+50 SR-460	Crossing	Intermittent Stream	CBW: 2-4', TOB: 5-6', BH: 3-4', Soil and gravel substrate, No flow. Banks were moderately unstable, 0-80% canopy coverage – oak, sweetgum, hickory, eastern red cedar. No aquatic fauna observed.

Photograph 7: Fayette County, STR-2 facing upstream (north), no feature on USGS map; May 3, 2006.

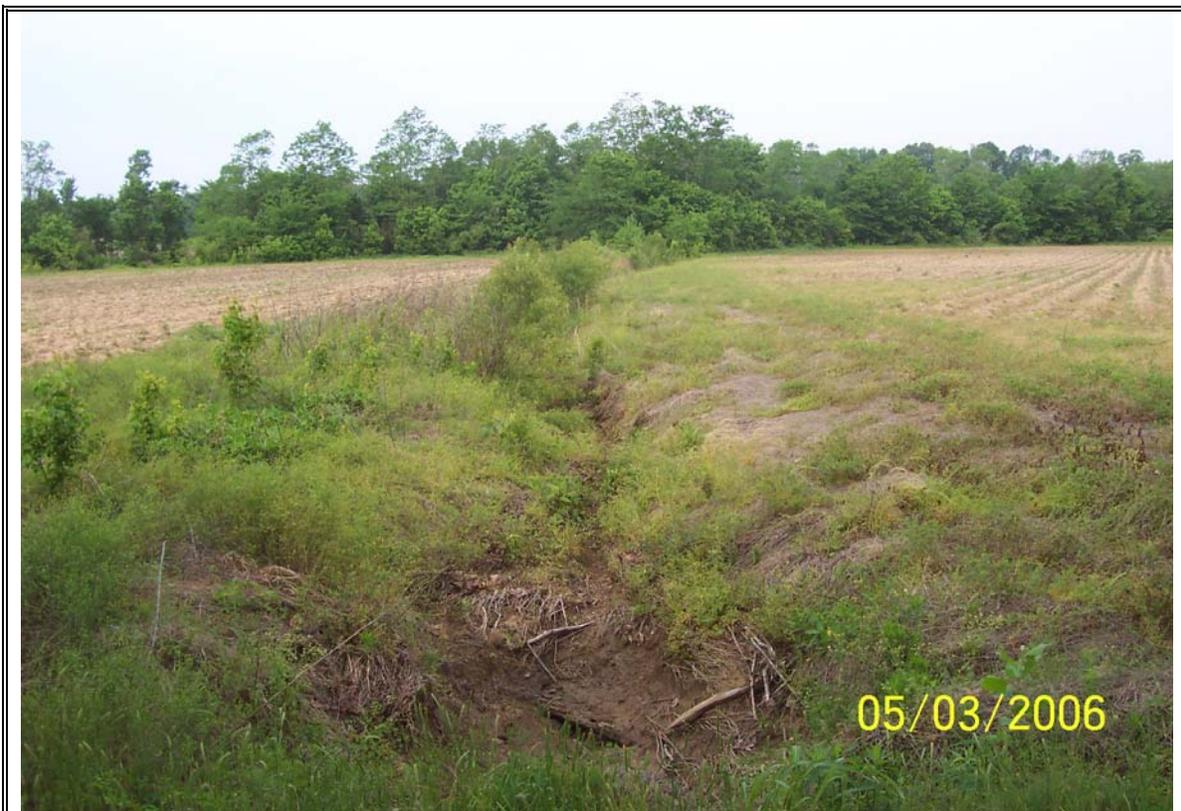
Photograph 8: Fayette County, STR-2 facing downstream, no feature on USGS map (south); May 3, 2006.

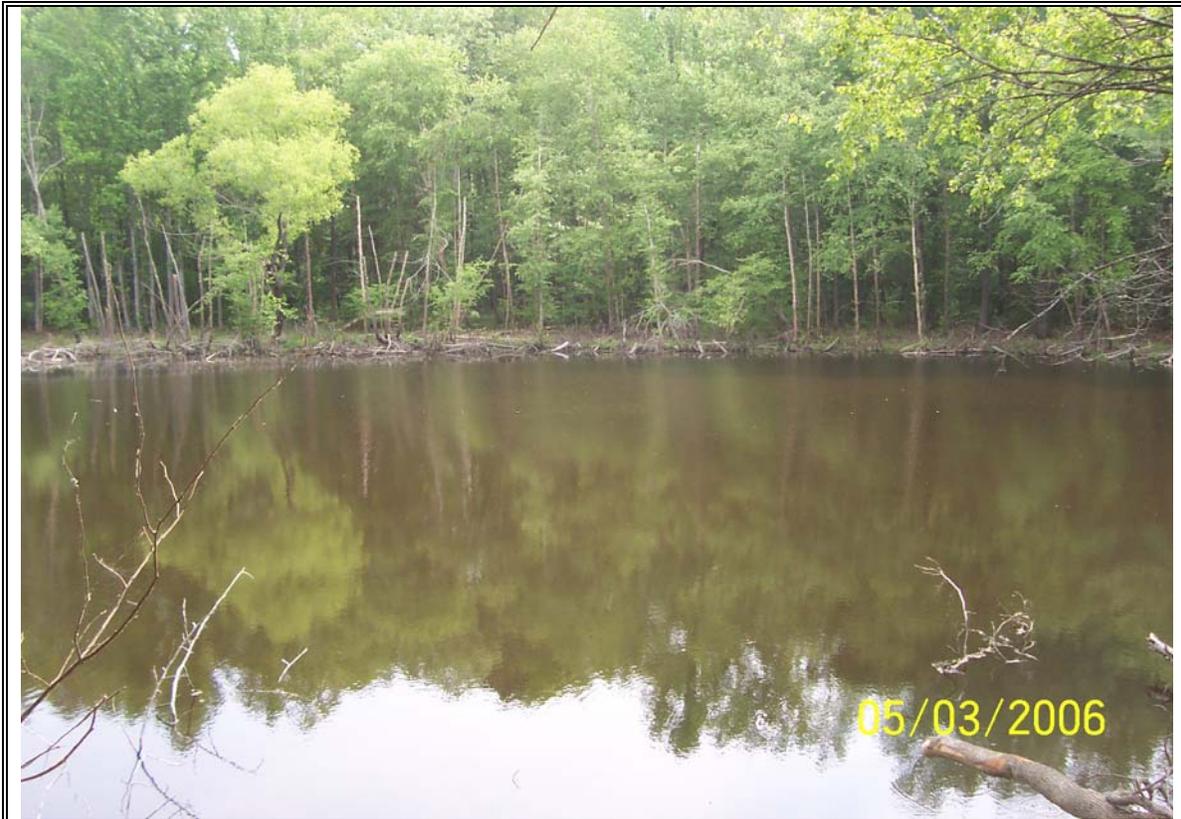
Stream watercourse waterbody	Project Segment	Location	Potential Impacts	Legal Designation (confirmed/unconfirmed)	Stream/Watercourse/Waterbody Description
PND-1	Section 1	STA 26+50L to 29+50R SR-460	Drain/fill	Isolated farm pond	Isolated farm pond that is shown on the topographic map.
STR-3 Unnamed tributary to Jones Creek	Section 1	STA 27+50 SR-460	Crossing	Perennial Stream	CBW: 2-5', TOB: 8-10', BH: 2-3', Soil substrate, WD:1-4", WW – 6"-1'. Banks were moderately unstable, 0-60% canopy coverage – willow oak, sycamore, box elder. Turtle and tadpoles observed. Stream flows through small linear wetland.
STR-4 Unnamed tributary to Jones Creek	Section 1	STA 37+00L SR-460	Crossing	Intermittent Stream	CBW: 1-2', TOB: 3-4', BH: 1-3', Soil substrate, No flow. Banks were unstable. 0-60% canopy coverage – box elder, eastern red cedar, American elm. No aquatic fauna observed.
STR-5 Unnamed tributary to Jones Creek	Section 1	STA 37+00 SR-460	Crossing	Intermittent Stream	CBW: 3-5', TOB: 4-7', BH: 3-4', Soil substrate, No flow. Banks were moderately unstable, 0-80% canopy coverage – willow oak, sycamore, box elder. No aquatic fauna observed.

Photograph 9: Fayette County, PND-1 facing north standing on south edge, shown on USGS map; May 3, 2006.

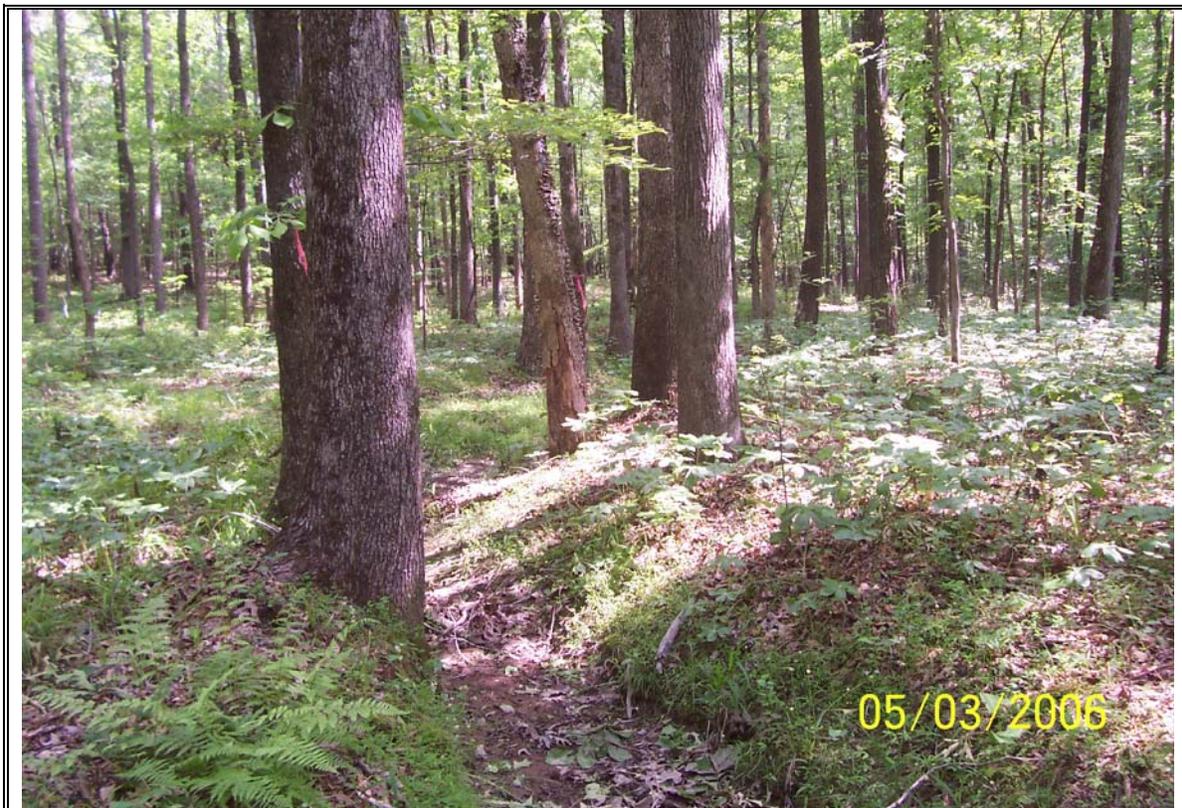
STR-6 Unnamed tributary to Jones Creek	Section 1	STA 49+50 SR-460	Crossing	Intermittent Stream	CBW: 2-4', TOB: 3-5', BH: 1-2', Soil substrate, No flow. Banks were moderately unstable, 80% canopy coverage –sweetgum, box elder, hickory, red maple. No aquatic fauna observed.
STR-7 Unnamed tributary to Town Branch	Section 1	STA 51+50 SR-460	Crossing	Intermittent Stream	CBW: 4-8', TOB: 6-15', BH: 2-5', Soil substrate, No flow. Some small pools present. Banks were moderately unstable, 85% canopy coverage – sweetgum, box elder, hickory, red maple. Water striders and crayfish observed.

Photograph 16: Fayette County, STR-6 facing upstream (northeast), no feature on USGS map; May 3, 2006.

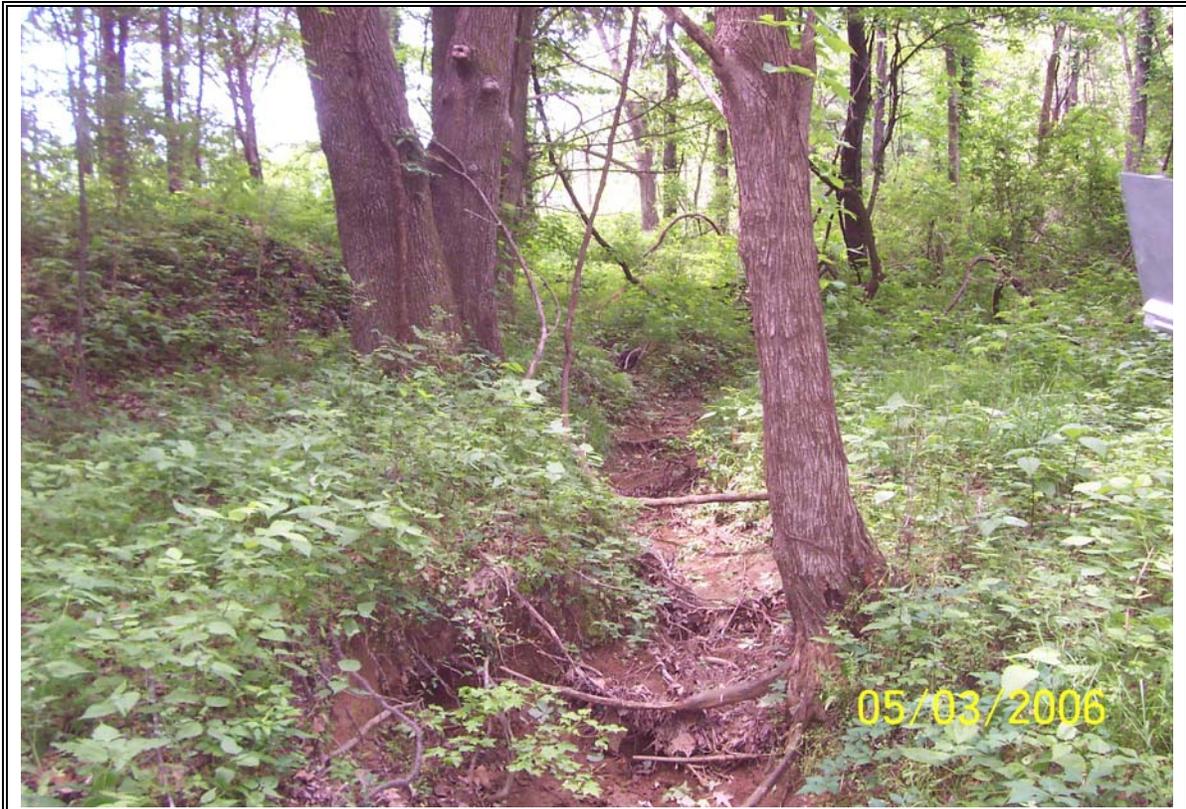
WWC-5	Section 1	STA 89+90 SR-460	Fill	Wet weather conveyance	CBW: 2-3', TOB: 3-4', BH: 1-3', Soil substrate, No flow. Banks were unstable, 50% canopy coverage –American elm, boxelder, oak. No aquatic fauna observed.
WWC-6	Section 1	STA 91+00 SR-460	Fill	Wet weather conveyance	CBW: 2-4', TOB: 3-5', BH: 1-4', Soil substrate, No flow. Banks were moderately unstable, 60% canopy coverage –American elm, boxelder, oak. No aquatic fauna observed.

Photograph 25: Fayette County, WWC-5 facing upstream (south), no feature on USGS map; May 3, 2006.

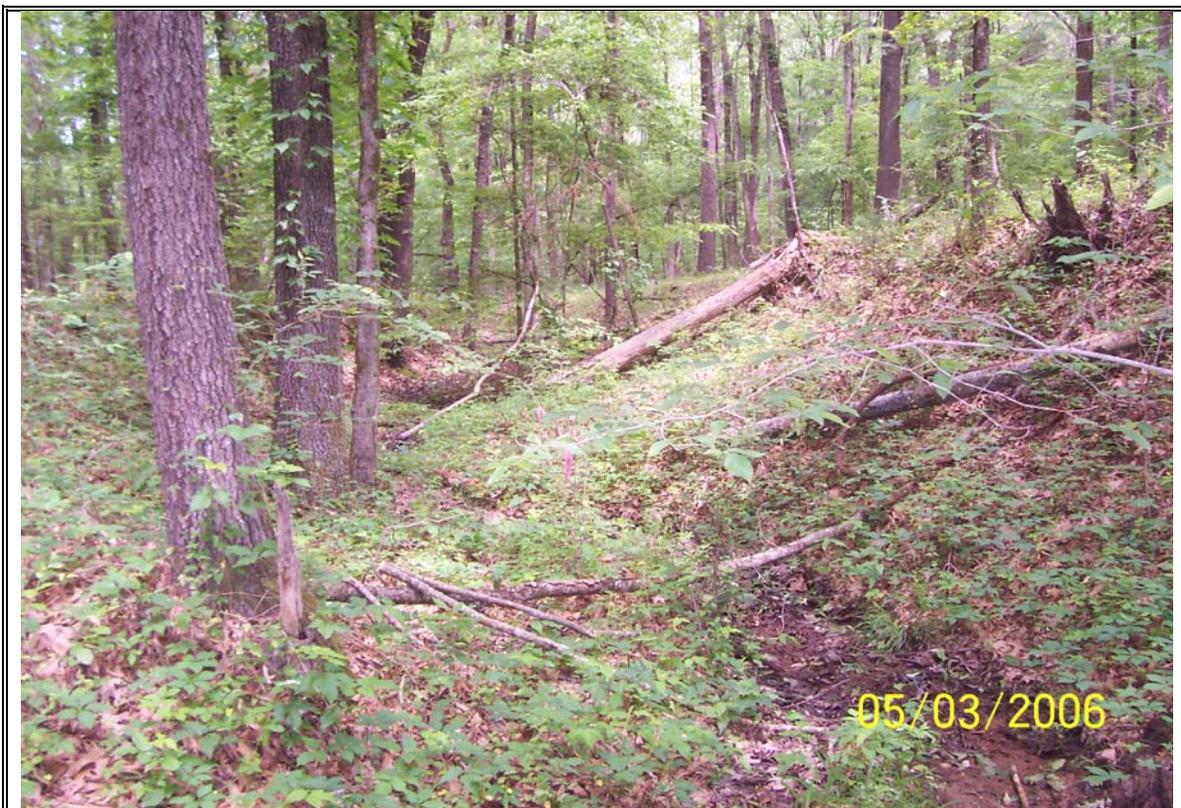
Stream watercourse waterbody	Project Segment	Location	Potential Impacts	Legal Designation (confirmed/unconfirmed)	Stream/Watercourse/Waterbody Description
STR-9 Unnamed tributary to Town Branch	Section 1	STA 94+00 SR-460	Crossing	Intermittent Stream	CBW: 4-5', TOB: 6-9', BH: 3-5', Soil substrate, No flow. Some small pools present. Banks were moderately unstable, 80% canopy coverage – American elm, boxelder, oak. No aquatic fauna observed.
WWC-7	Section 1	STA 98+60L to 103+30L SR-460	Fill	Wet weather conveyance	CBW: 2-4', TOB: 3-5', BH: 1-4', Soil substrate, No flow. Banks were moderately unstable, 0-60% canopy coverage –American elm, boxelder, oak. No aquatic fauna observed.
STR-10 Unnamed tributary to Town Branch	Section 1	STA 102+00 SR-460	Crossing	Intermittent Stream	CBW: 3-5', TOB: 6-10', BH: 1-3', Soil substrate, No flow. Some small pools present. Banks were moderately unstable, 70% canopy coverage – American elm, red maple, oak. No aquatic fauna observed.

Photograph 28: Fayette County, STR-9 facing downstream (north), intermittent on USGS map; May 3, 2006.

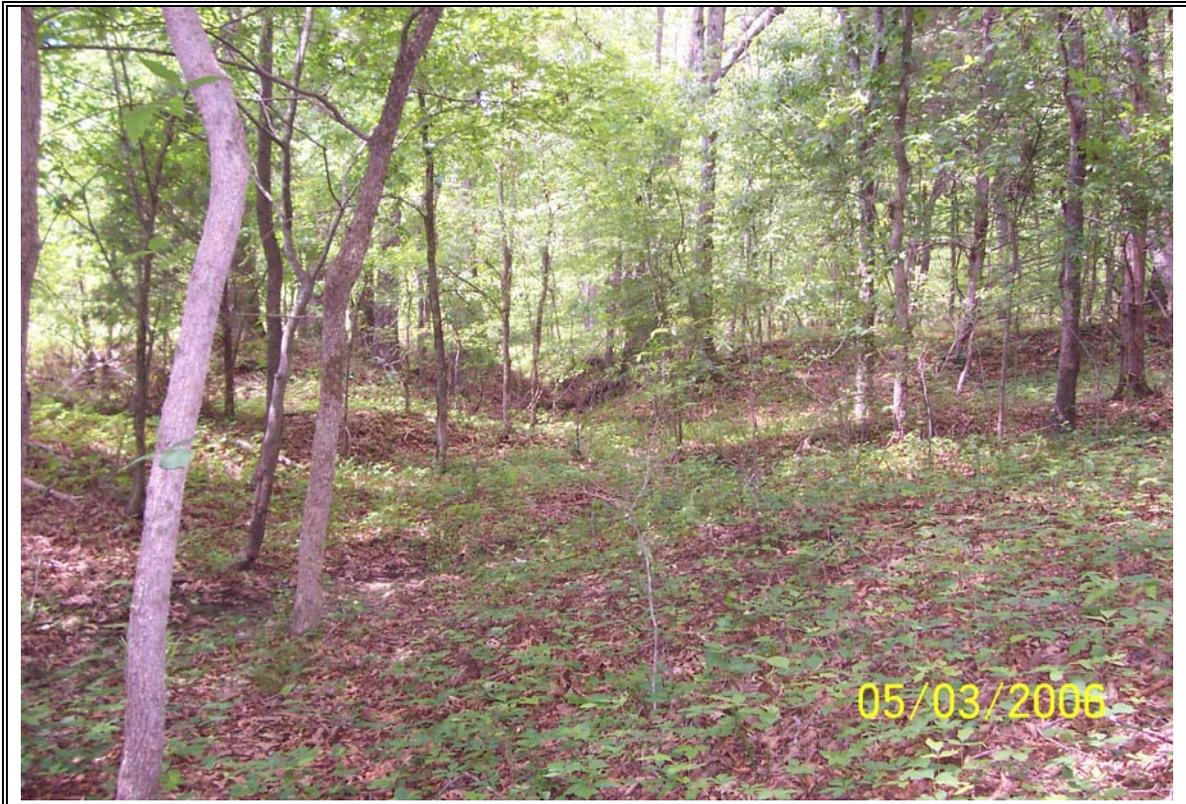
WWC-8	Section 1	STA 106+00L SR-460	Runoff	Wet weather conveyance	CBW: 1-2', TOB: 1-3', BH: 6"-1', Soil and sand substrate, No flow. Banks were unstable, 80% canopy coverage –American elm, red maple, eastern red cedar, oak. No aquatic fauna observed.
WWC-9	Section 1	STA 113+00L to 114+50L SR-460	Fill	Wet weather conveyance	CBW: 1-2', TOB: 2-3', BH: 1-3', Soil substrate, No flow. Banks were moderately unstable, 70% canopy coverage –American elm, oak. No aquatic fauna observed.

Photograph 33: Fayette County, WWC-8 facing downstream (north), no feature on USGS map; May 3, 2006.

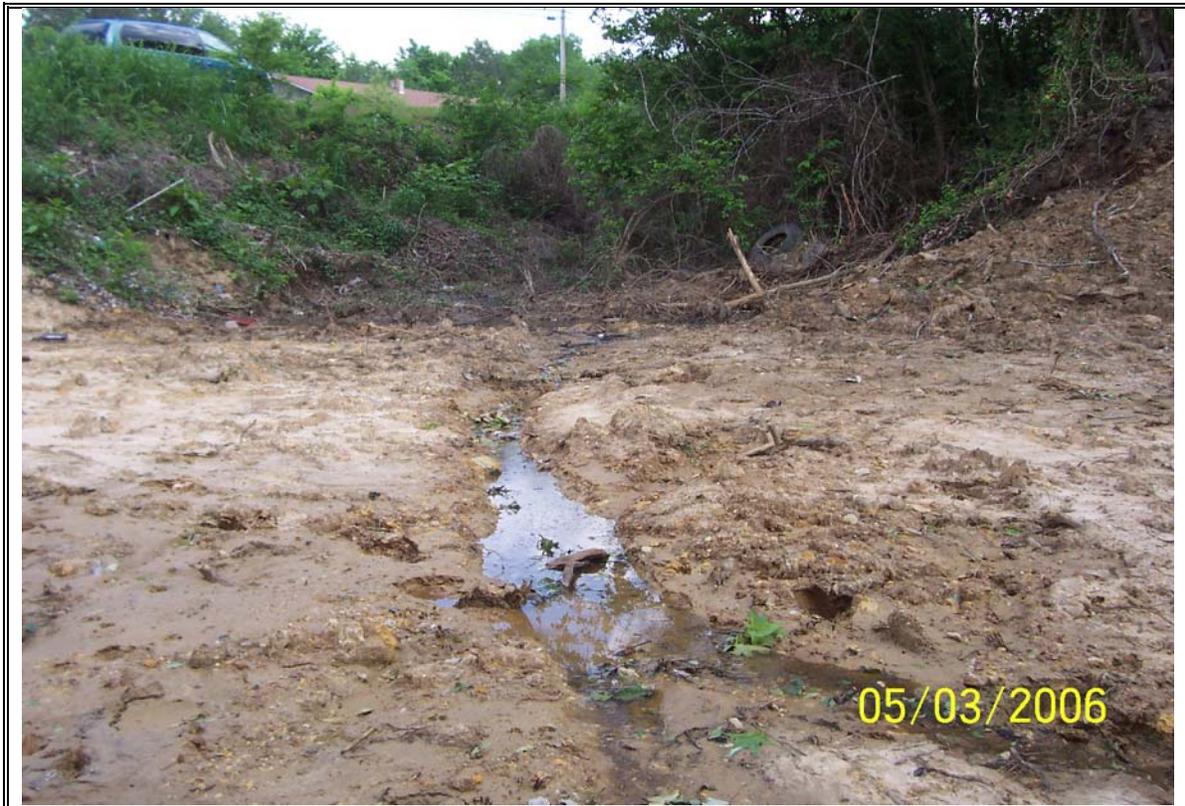
Stream watercourse waterbody	Project Segment	Location	Potential Impacts	Legal Designation (confirmed/unconfirmed)	Stream/Watercourse/Waterbody Description
SEP-2	Section 1	STA 19+20L Ramp 5	Fill	Seep	Channel not well defined. CBW: 6"-2', TOB: 1-3', BH: 6"-1', Soil substrate, Very low flow. 0.5-3" deep pooled areas. Banks were unstable, 0-30% canopy coverage – black locust, sweetgum, red maple. No aquatic fauna observed.
WWC-14	Section 2	STA 155+00 SR-460	Fill	Wet weather conveyance	CBW: 1-3', TOB: 3-5', BH: 6"-1', Soil substrate, No flow. Banks were unstable, 50% canopy coverage –American elm, hickory, oak. No aquatic fauna observed.
WWC-15	Section 2	STA 182+75 SR-460	Fill	Wet weather conveyance	CBW: 2-3', TOB: 3-5', BH: 2-3', Soil substrate, No flow. Banks were moderately unstable, 0-30% canopy coverage –sweetgum, honey locust. No aquatic fauna observed.
WWC-16	Section 2	STA 189+00R SR-460	Fill	Wet weather conveyance	CBW: 1-3', TOB: 2-4', BH: 2-4', Soil substrate, No flow. Banks were stable, 0-60% canopy coverage – sweetgum, honey locust. No aquatic fauna observed.

Photograph 49: Fayette County, SEP-2 facing south, no feature on USGS map; May 3, 2006.

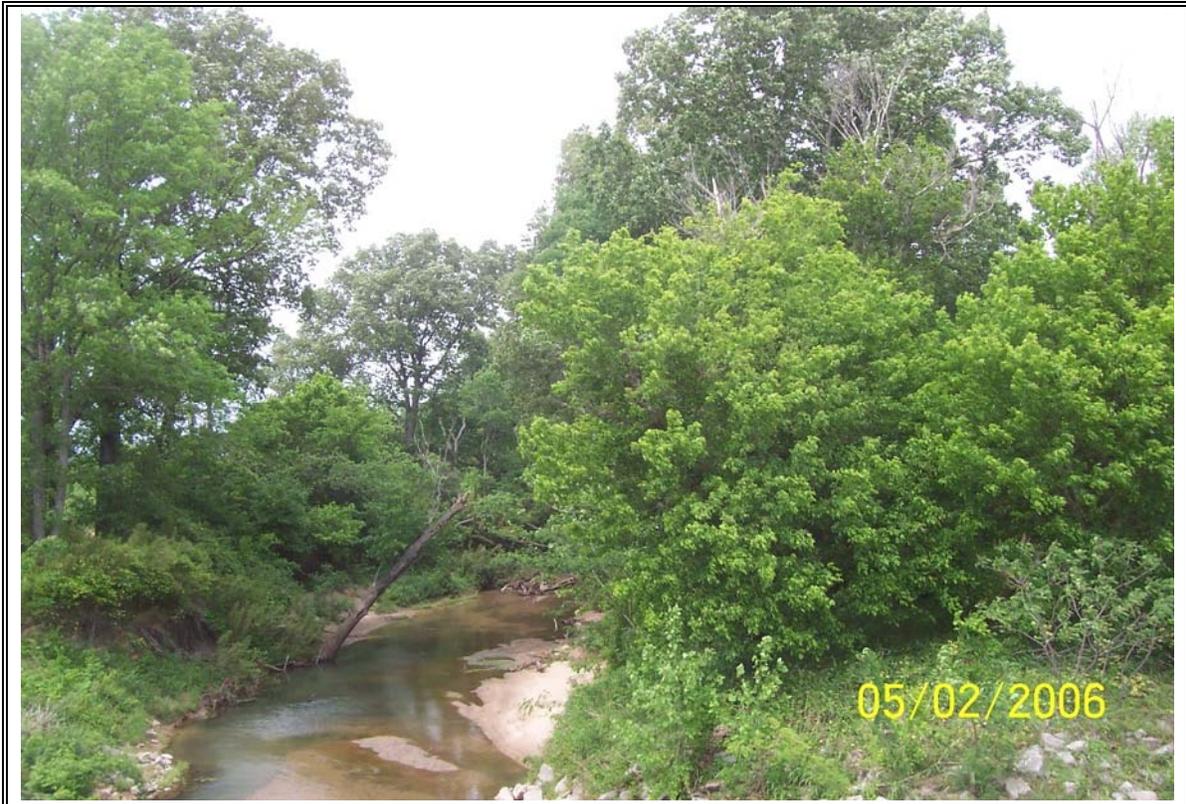
STR-16 Bennetts Creek	Section 3	STA 23+30 Ramp 9a	Crossing	Perennial Stream	CBW: 30-50', TOB: 40-60', BH: 3-5', Soil substrate, WD: 3"-1', WW – 15-35'. Banks were unstable, 0-50% canopy coverage –river birch, boxelder, sweetgum, sycamore. No aquatic fauna observed.
WWC-22	Section 3	STA 24+00L to 27+50R Ramp 9a	Fill	Wet weather conveyance	CBW: 1-2', TOB: 2-4', BH: 1-3', Soil substrate, No flow. Banks were unstable, 0-30% canopy coverage – sweetgum, sycamore, tree of heaven, black willow. No aquatic fauna observed.

Photograph 73: Fayette County, STR-16 facing downstream (north), perennial on USGS map; May 2, 2006.

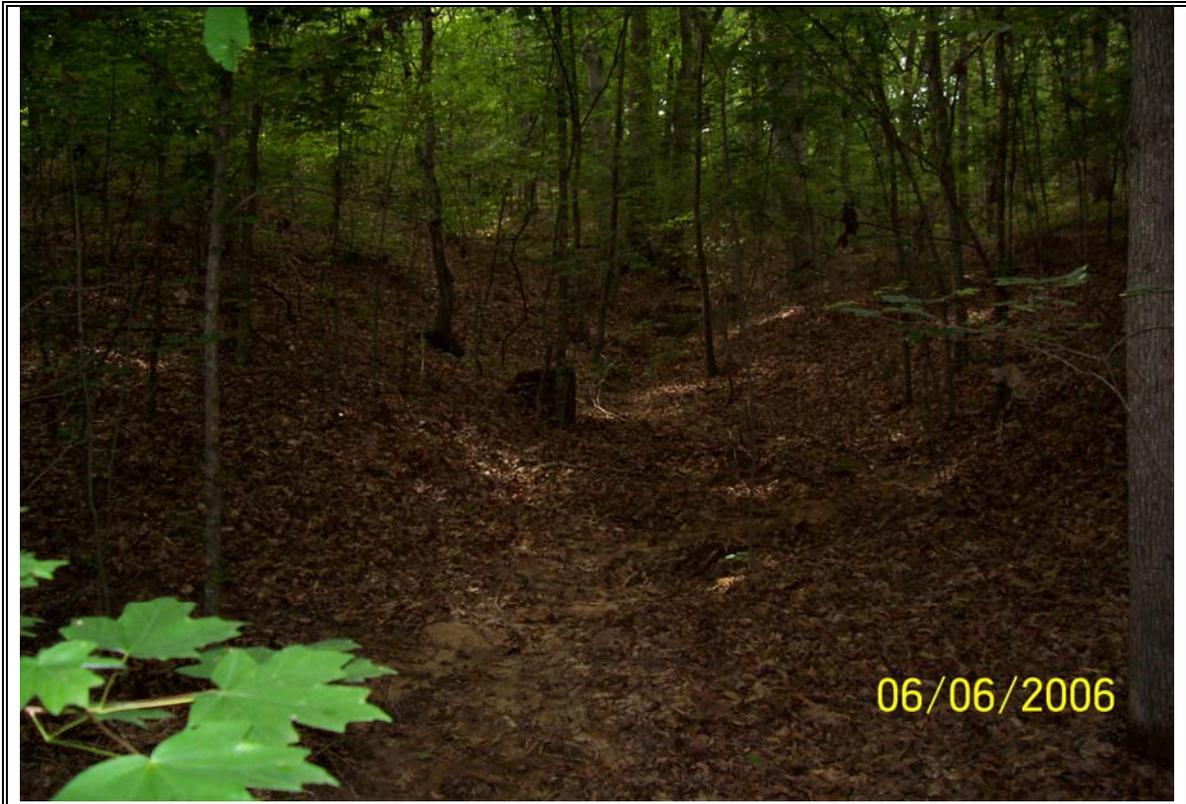
WWC-32	Section 3	STA 325+00 SR-460	Fill	Wet weather conveyance	CBW: 1-3', TOB: 2-4', BH: 6"-1', Soil and sand substrate, No flow. Banks were unstable, 80% canopy coverage – oak, red maple, American elm, American beech. No aquatic fauna observed.

Photograph 102: Fayette County, WWC-32 facing upstream (northwest), no feature on USGS map; June 6, 2006.

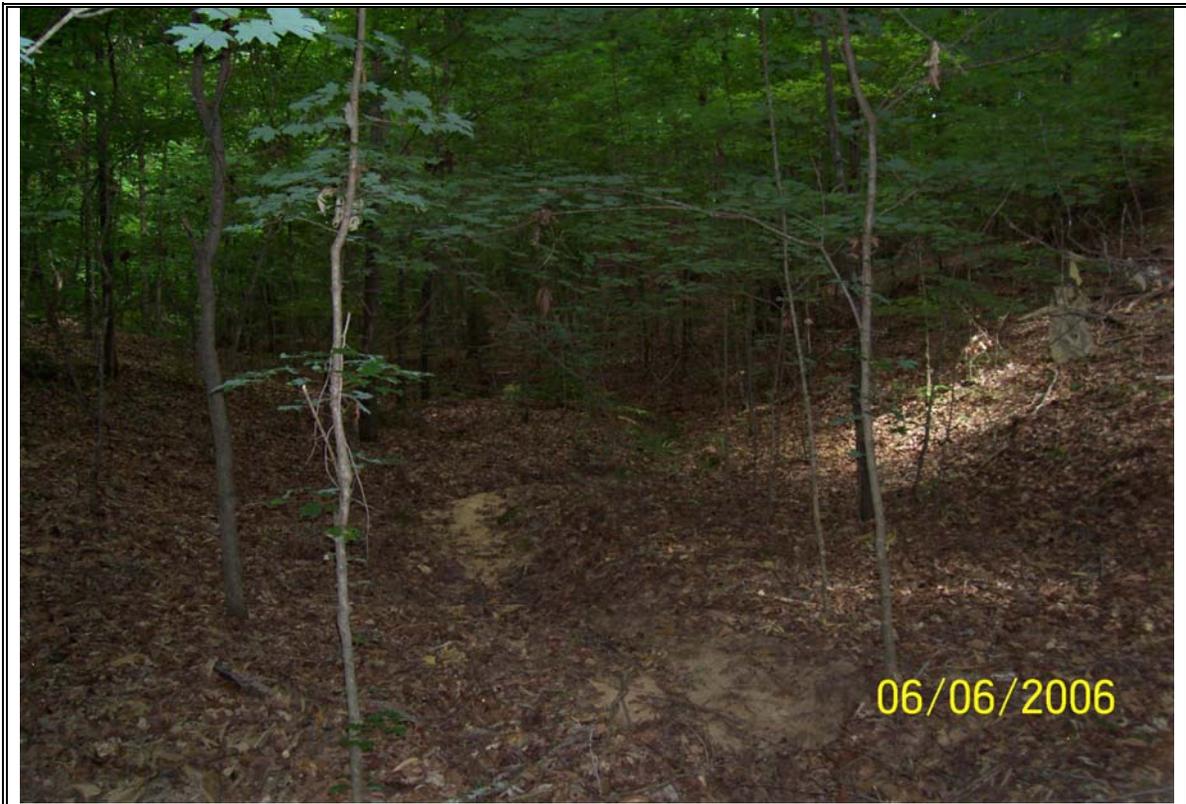
Photograph 103: Fayette County, WWC-32 facing downstream (southeast), no feature on USGS map; June 6, 2006.
