Treatment Resource Guide: Historic Windows

Windows are considered a character-defining features of a building. “When historic windows exist, they should be repaired when possible. When they are too deteriorated to repair, selection of the replacement windows must be guided by [Standard 6](#). Design, visual qualities, and materials are specific criteria provided by the Standard that are pertinent to evaluating the match of a replacement window. Evaluating the adequacy of the match of the replacement window involves the consideration of multiple issues.” Existing windows must be repaired rather than replaced. If these windows are deteriorated beyond what is technically or feasibly-appropriate repair, thorough documentation of the need for replacement **must** be submitted before any replacement windows should be installed.

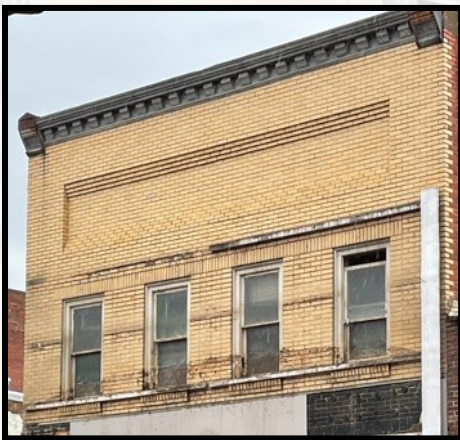
Matching the appearance and design of historic windows is vital component of replacement window considerations.

In this example, the replacement windows (right) do not match the appearance, size, design, profiles, or proportions of the historic windows (left).

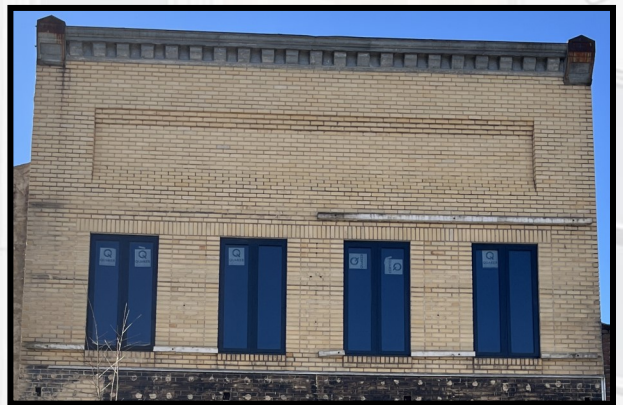
Proposed Replacement Windows

Why might the proposed replacement windows not meet the *Standards*?

- ◆ The existing windows can, and should, be repaired. There is not adequate documentation to show that replacement is necessary.
- ◆ Proposed replacement windows do not match the appearance, size, design, proportions or profiles of the existing windows.
- ◆ Proposed replacement windows are generally incompatible with the historic character of the building.
- ◆ Documentation was not provided to show that the proposed replacement windows match the character of the building (when no windows currently exist).
- ◆ Proposed replacement windows give a false sense of historic development and character.
- ◆ Proposed replacement windows could not be properly evaluated because the required documentation (drawings of: elevation, horizontal sections, and vertical sections) was not provided.
